**Wetlands and Waters Delineation  
Report**

**Seldon Road Extension Phase II**

CFHWY00562

August 12, 2022

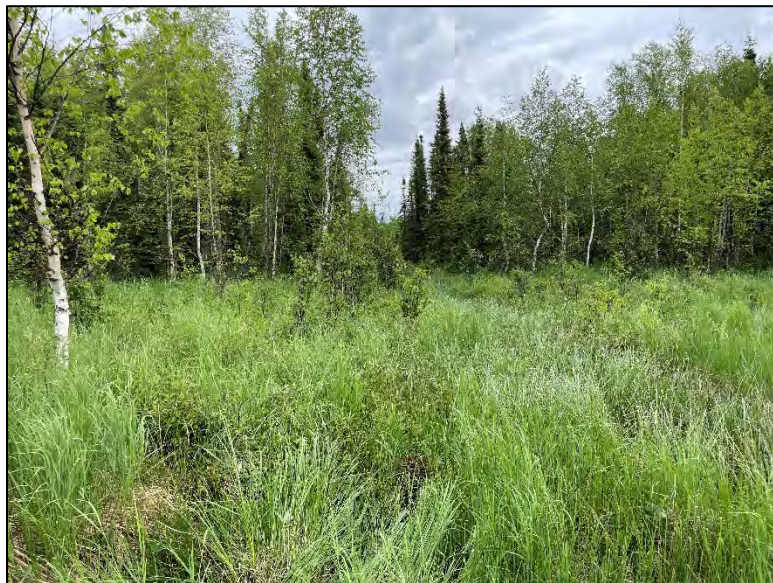
#### Photo 2 Riverine HGM Wetland

The majority of wetlands within the study area are classified as Slope wetlands (Photo 2). They are supported by discharge of groundwater from the Talkeetna Mountains to the north.

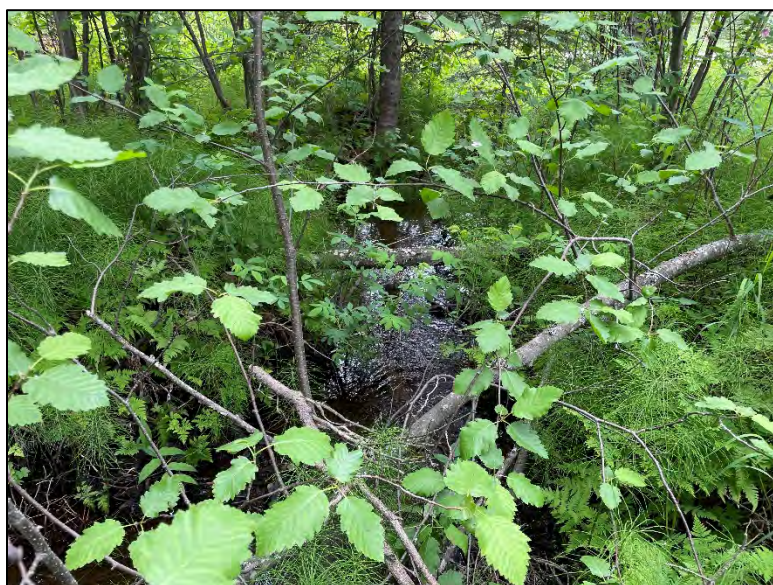
#### Photo 3 Riverine Channel Stream

The three unnamed streams intersecting the study area are considered Riverine Channel. The stream identified at data point ST053 is shown in Photo 3.

Three Perennial RPW streams were found within the study area (Figure 4, Appendix D). The NHD had mapped two streams in the study area but only one of these streams was verified. However, two additional streams were found that the NHD had not mapped.

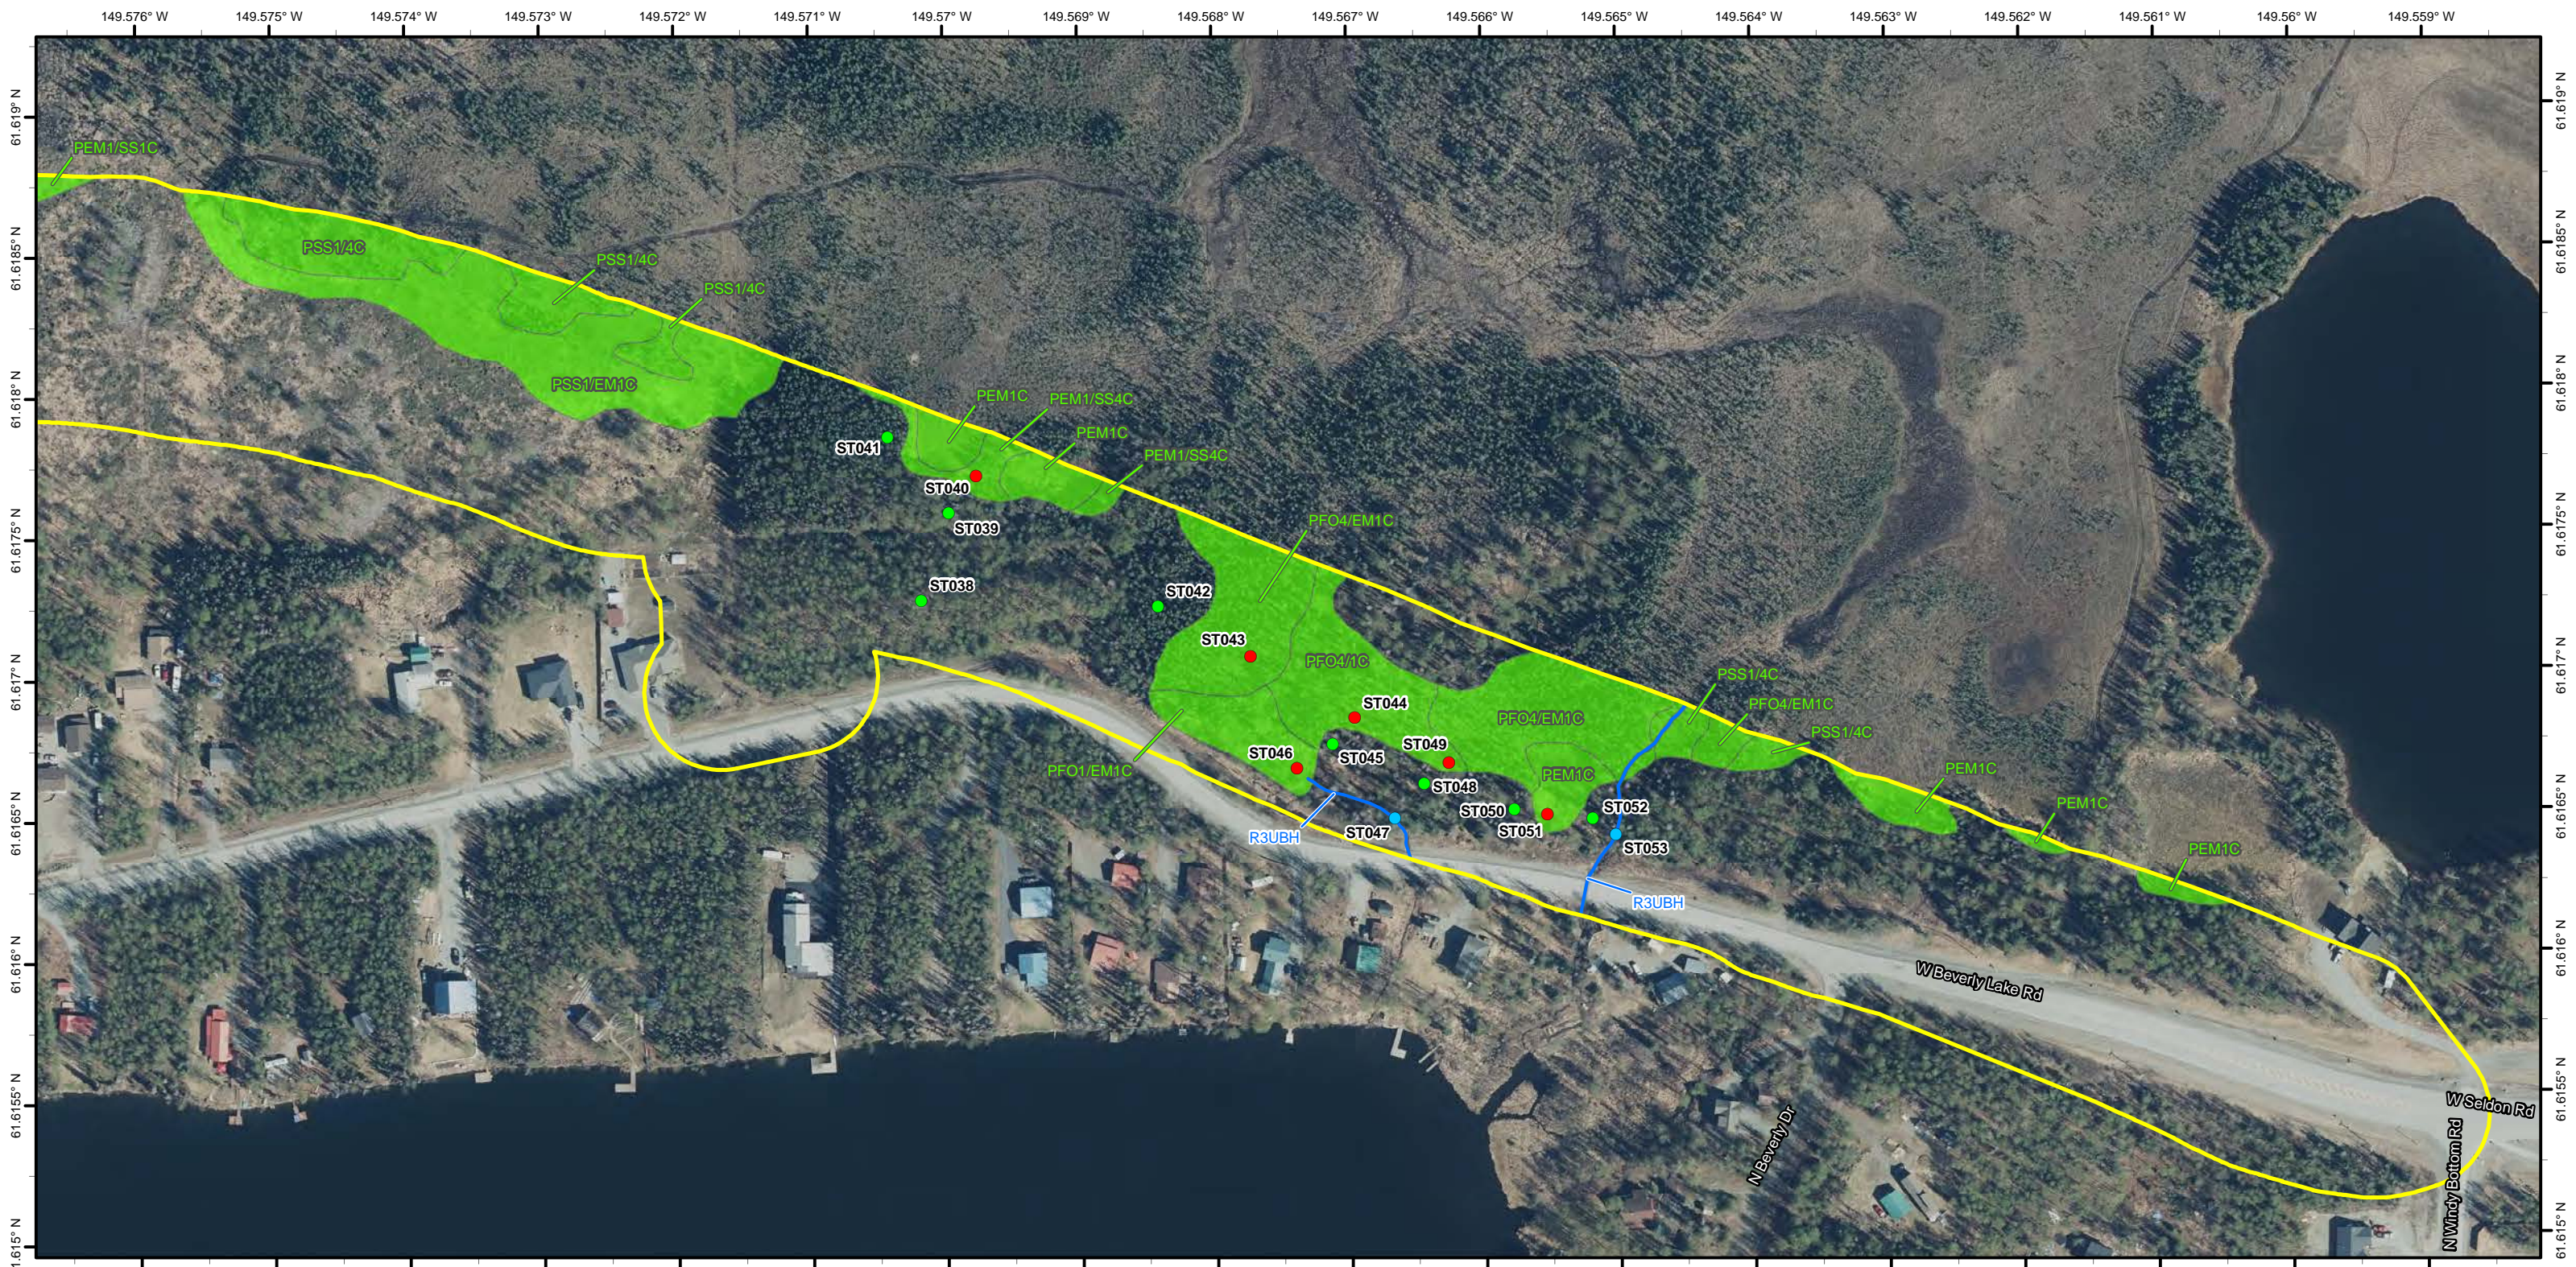
Figure Number  
**D - 1**

All data points have associated photographs with photo directions labeled in Appendix C. Field data forms are presented concurrently with photos in Appendix C.

The HGM classes identified in the study area are shown on the detailed figures in Appendix D and discussed in the following section. The HGM descriptions are taken from Wetland Functional Assessment Guidebook, Operational Draft Guidebook for Assessing the Functions of Slope/Flat Wetland Complexes in the Cook Inlet Basin Ecoregion Alaska, using the HGM Approach (Hall et al 2003), an application of the HGM approach for precipitation driven wetlands on discontinuous permafrost in Interior Alaska.

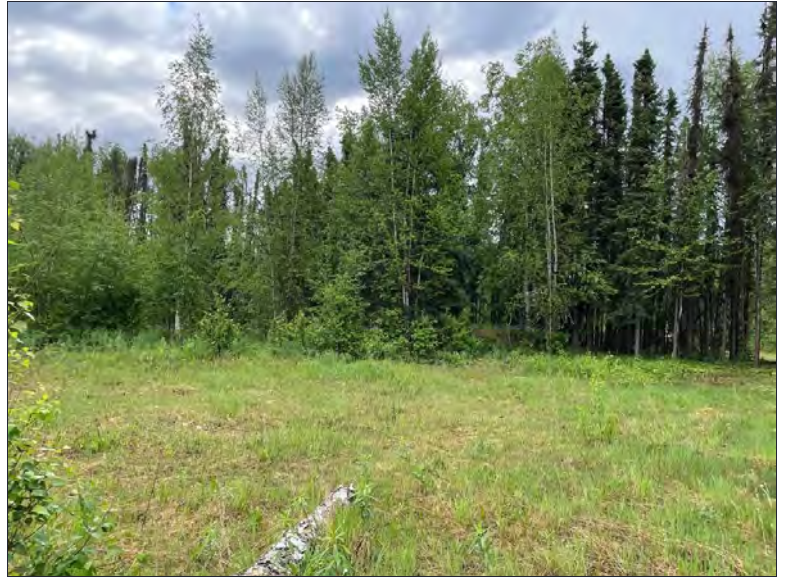
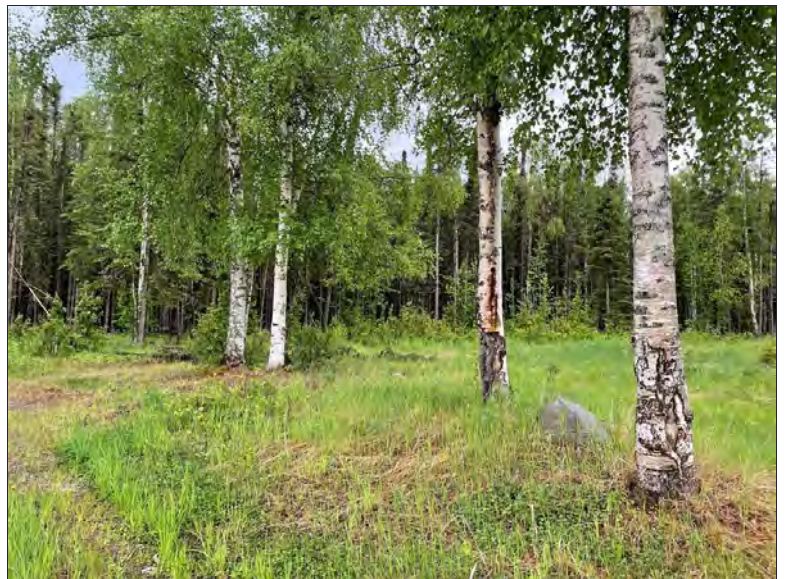
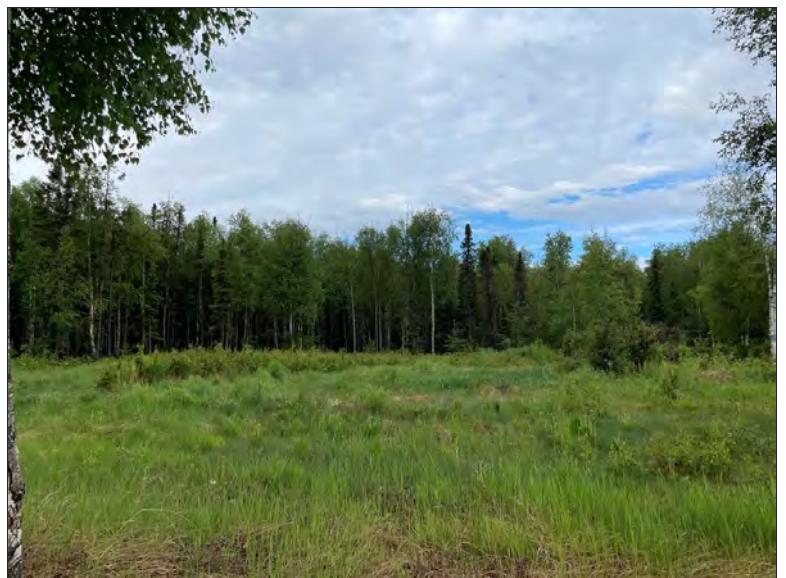
Plot Number	ST001
Wetland Status	Upland
Plot Type	FVP
Plot Date	6/9/2022
NWI Classification	U
HGM	N/A
Latitude (DD)	61.6177253214
Longitude (DD)	-149.591384877

Photo Type: Vegetation

Direction: E

Direction: S

Direction: W

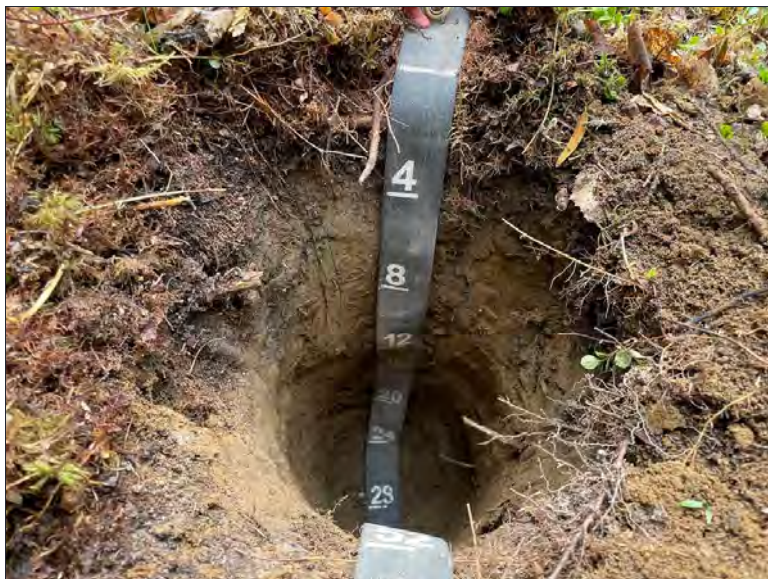
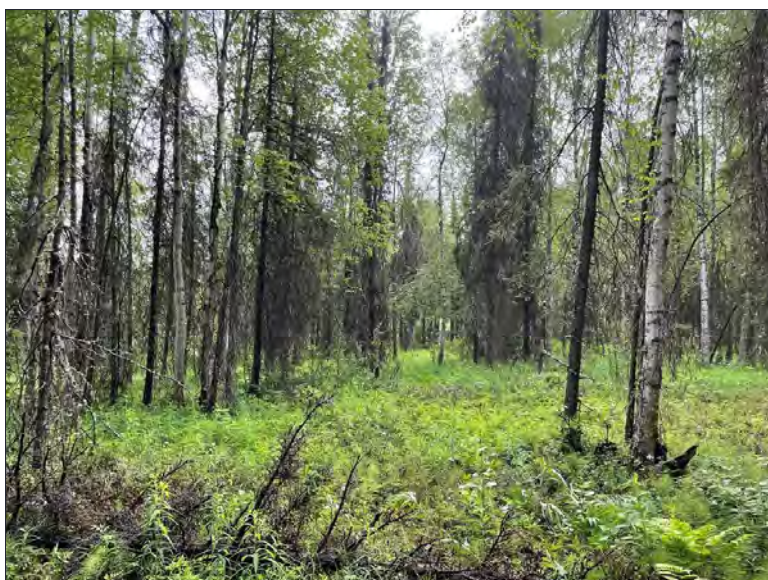
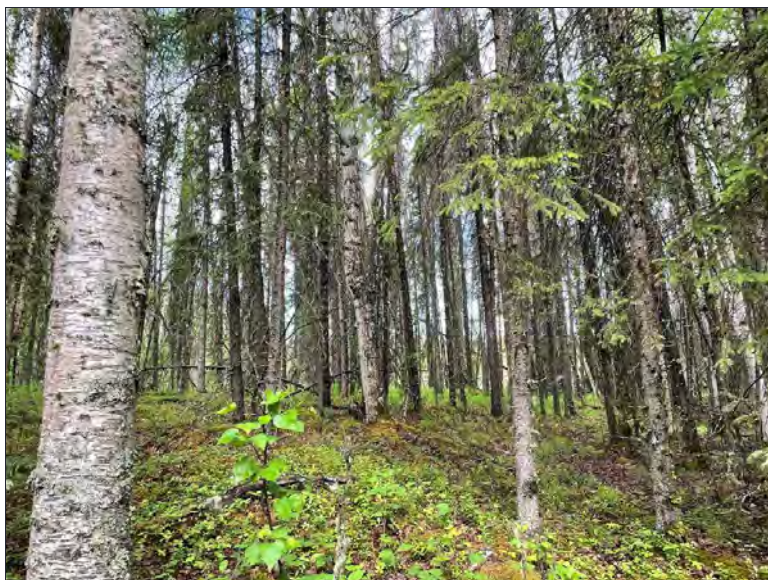
Plot Number	ST002
Wetland Status	Upland
Plot Type	WD
Plot Date	6/9/2022
NWI Classification	U
HGM	N/A
Latitude (DD)	61.6177068127
Longitude (DD)	-149.593455778

Photo Type: Soils

Photo Type: Vegetation

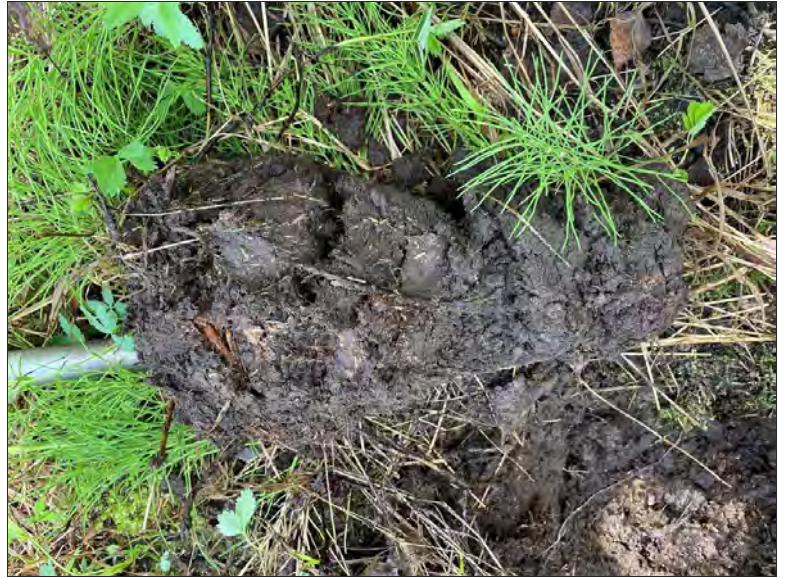
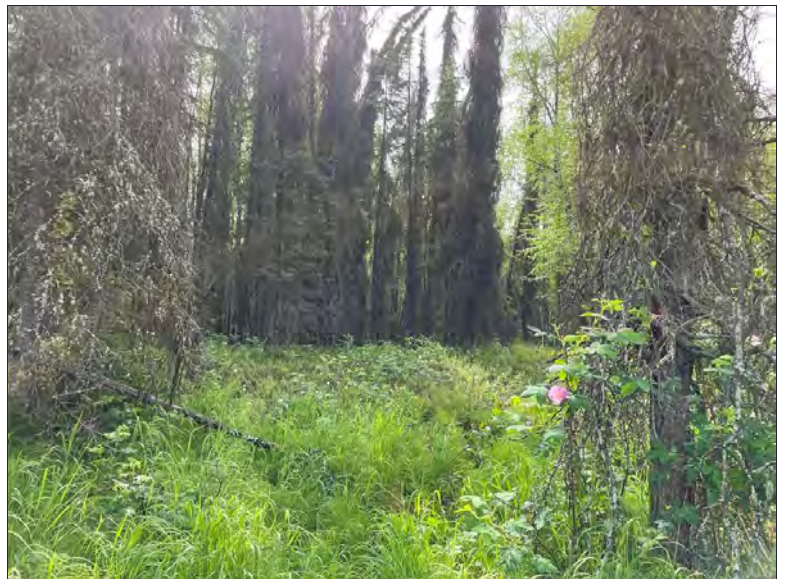
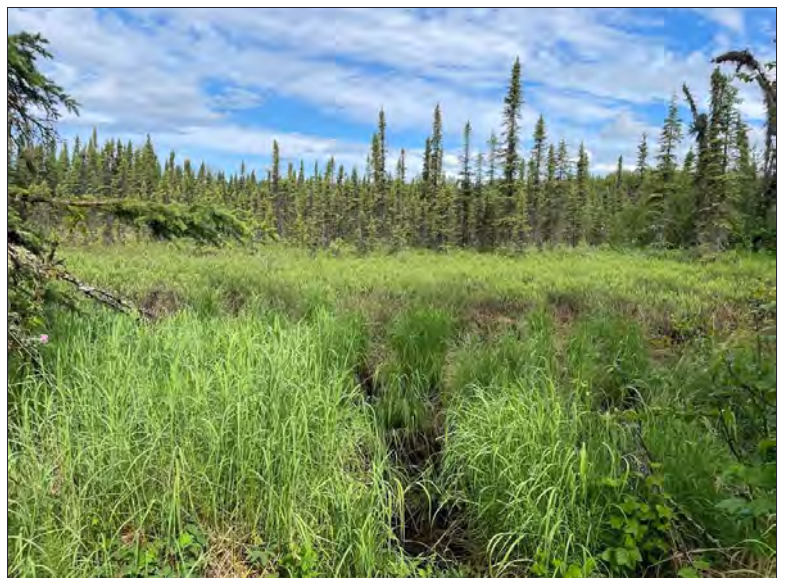
Plot Number	ST003
Wetland Status	Wetland
Plot Type	FVP
Plot Date	6/9/2022
NWI Classification	PSS1/EM1C
HGM	Slope
Latitude (DD)	61.617823906
Longitude (DD)	-149.594192248

Photo Type: Soils

Photo Type: Vegetation

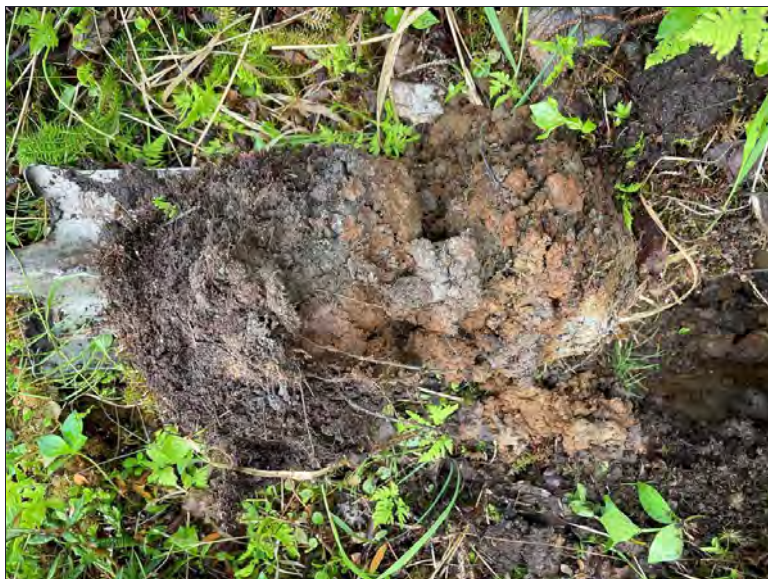
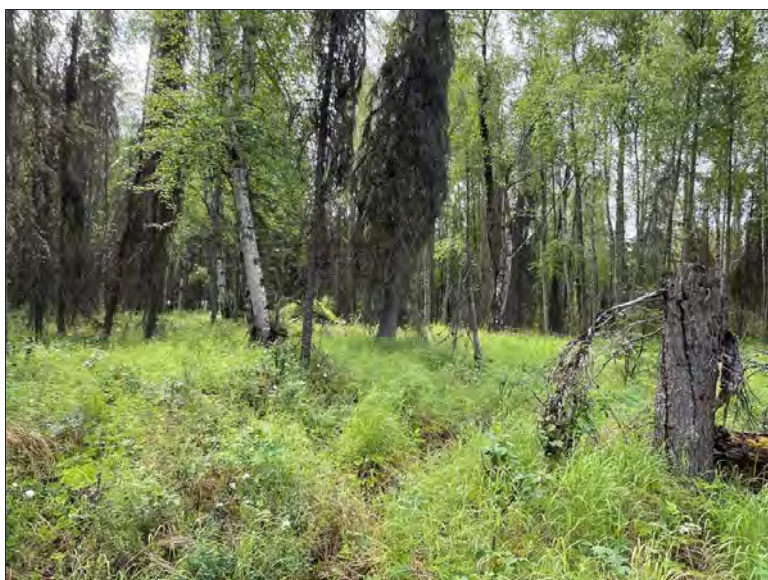
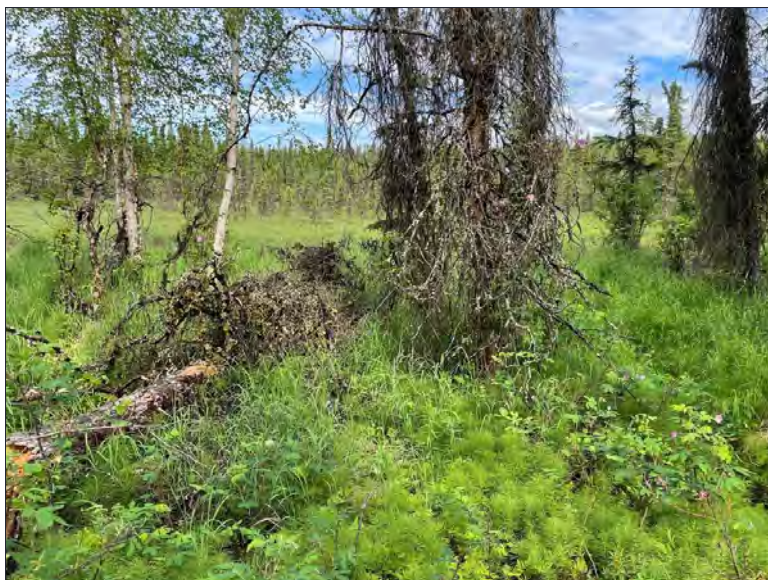
Plot Number	ST004
Wetland Status	Upland
Plot Type	FVP
Plot Date	6/9/2022
NWI Classification	U
HGM	N/A
Latitude (DD)	61.6177301924
Longitude (DD)	-149.59407732

Photo Type: Soils

Photo Type: Vegetation

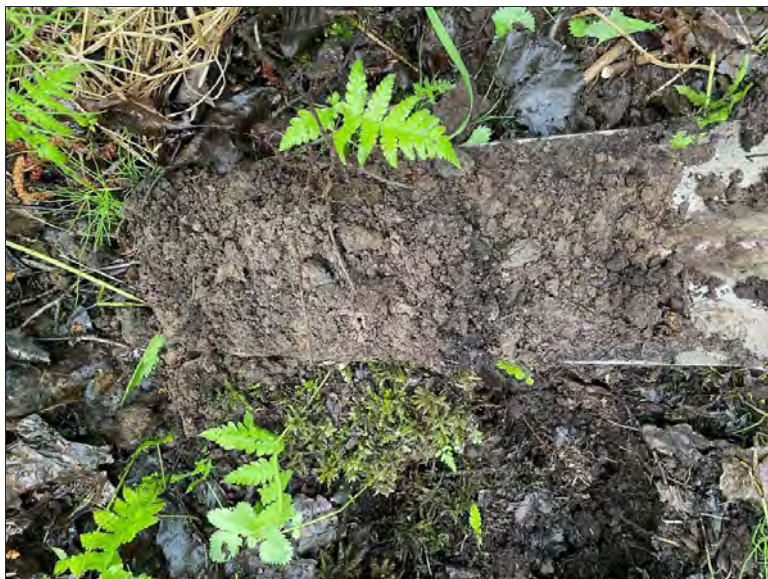
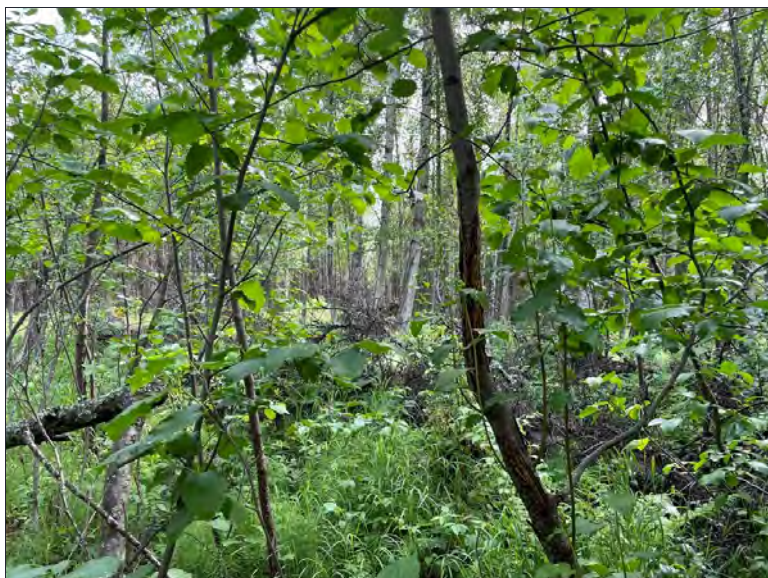
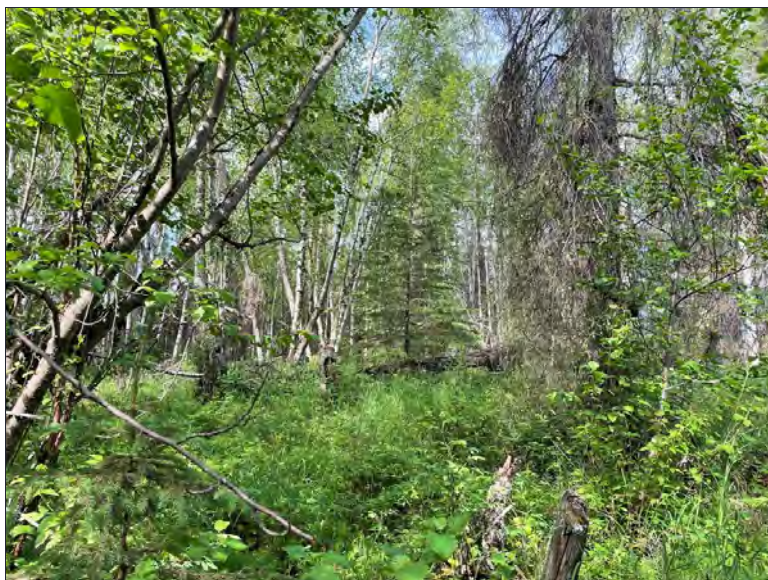
Plot Number	ST005
Wetland Status	Upland
Plot Type	FVP
Plot Date	6/9/2022
NWI Classification	U
HGM	N/A
Latitude (DD)	61.6174745809
Longitude (DD)	-149.594651309

Photo Type: Soils

Photo Type: Vegetation

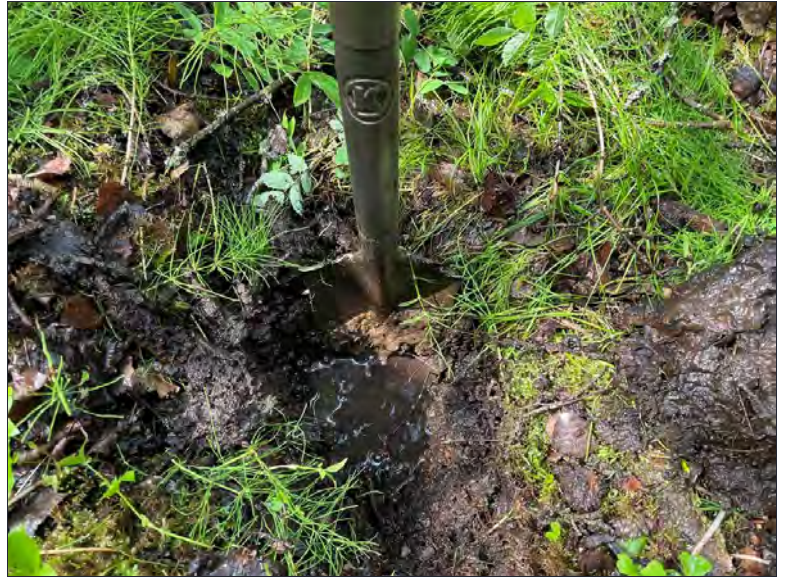
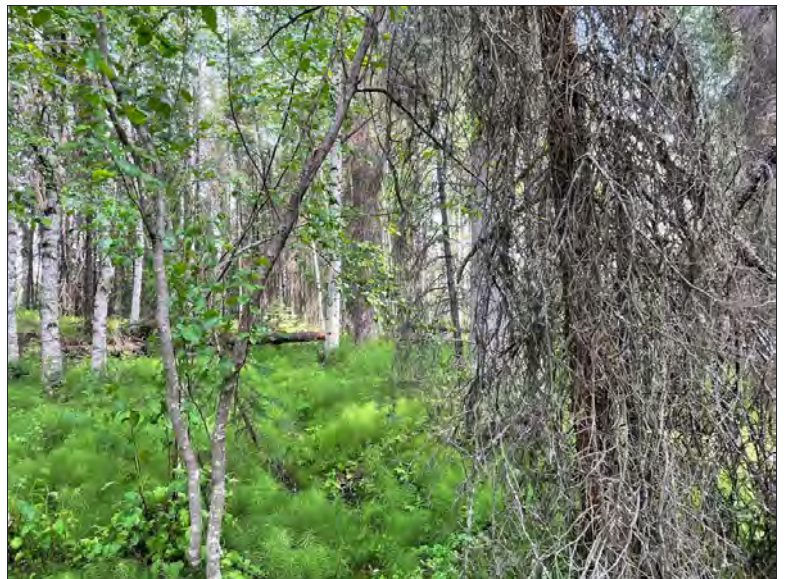
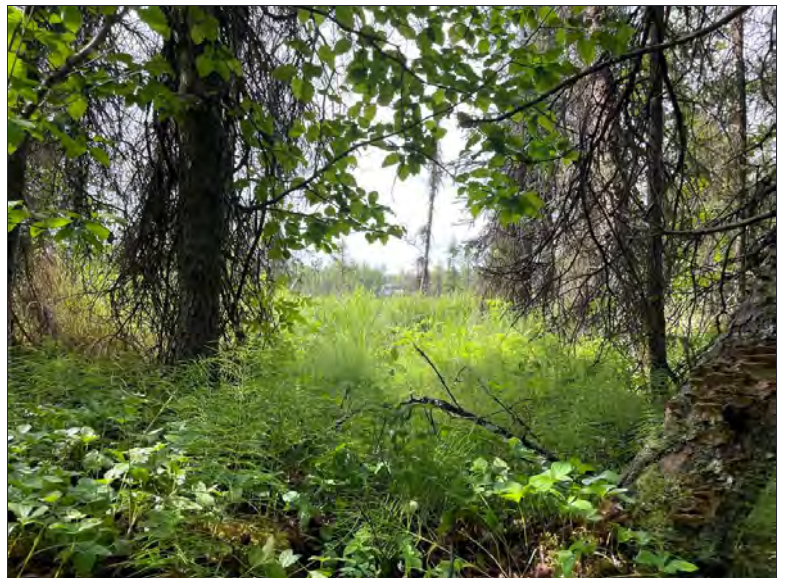
Plot Number	ST006
Wetland Status	Wetland
Plot Type	FVP
Plot Date	6/9/2022
NWI Classification	PFO4/SS1C
HGM	Slope
Latitude (DD)	61.6172887143
Longitude (DD)	-149.595661378

Photo Type: Soils

Photo Type: Vegetation

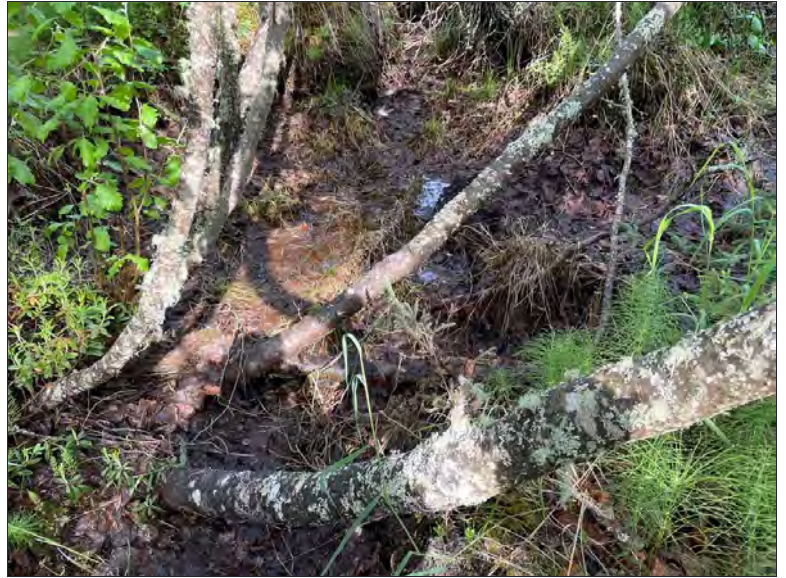
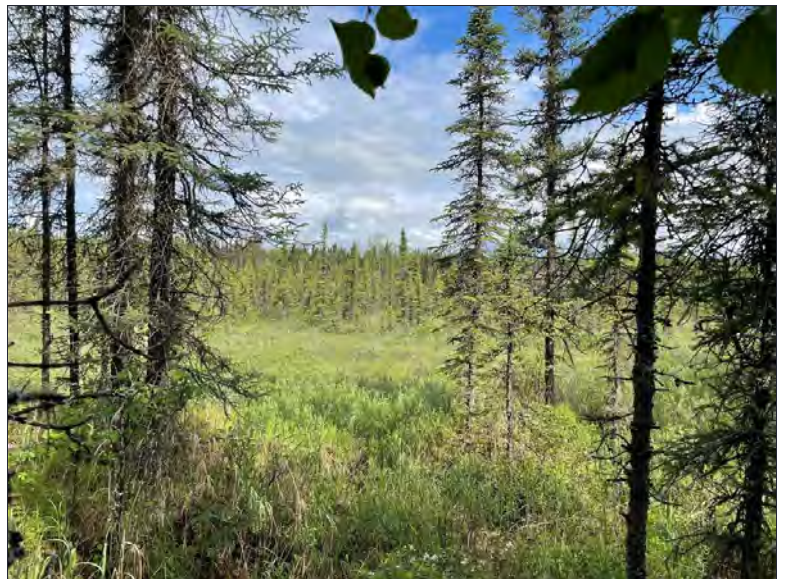
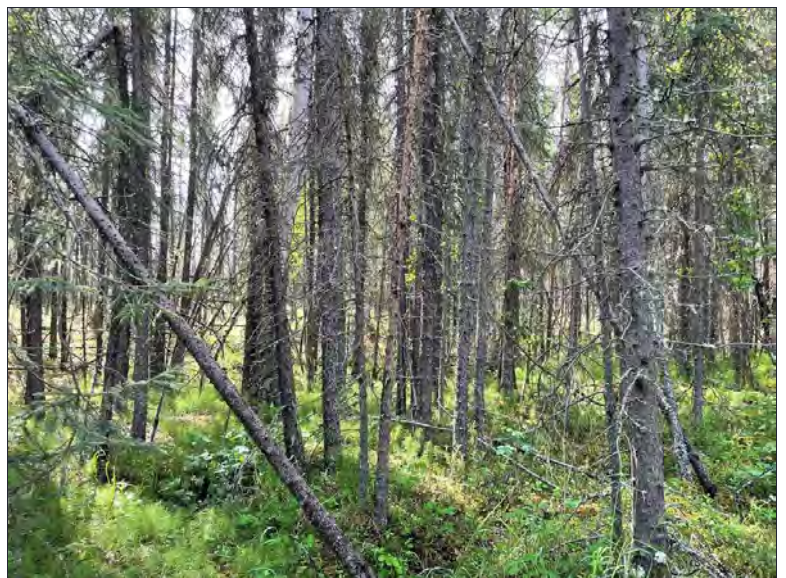
Plot Number	ST007
Wetland Status	Wetland
Plot Type	FVP
Plot Date	6/9/2022
NWI Classification	PFO4/SS1C
HGM	Slope
Latitude (DD)	61.617526435
Longitude (DD)	-149.596540797

Photo Type: Hydrology

Photo Type: Vegetation

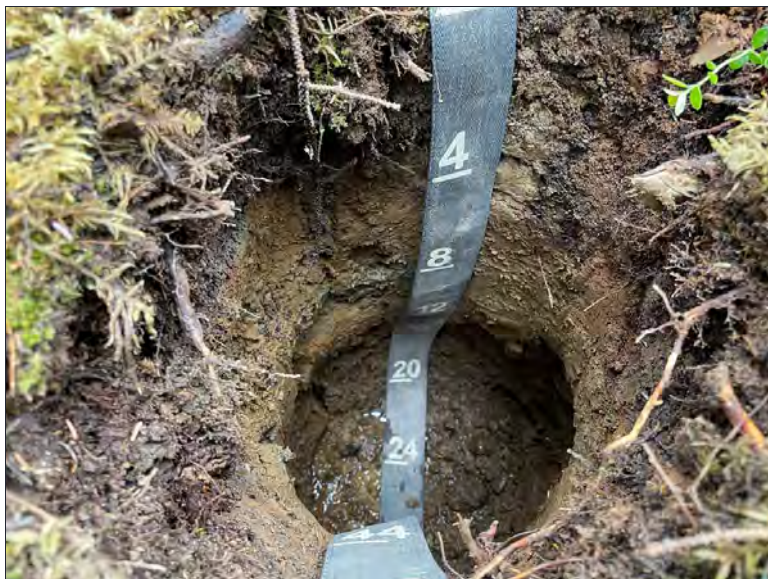
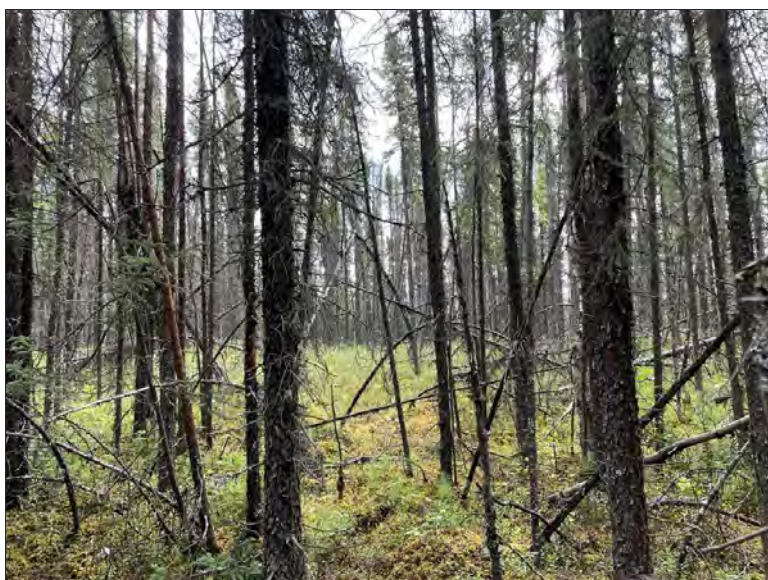
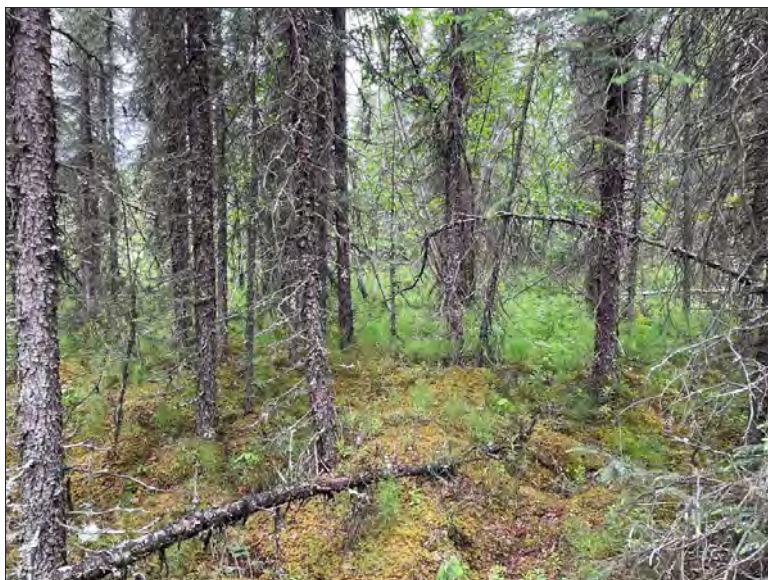
Plot Number	ST008
Wetland Status	Upland
Plot Type	WD
Plot Date	6/9/2022
NWI Classification	U
HGM	N/A
Latitude (DD)	61.617227989
Longitude (DD)	-149.59685505

Photo Type: Soils

Photo Type: Vegetation

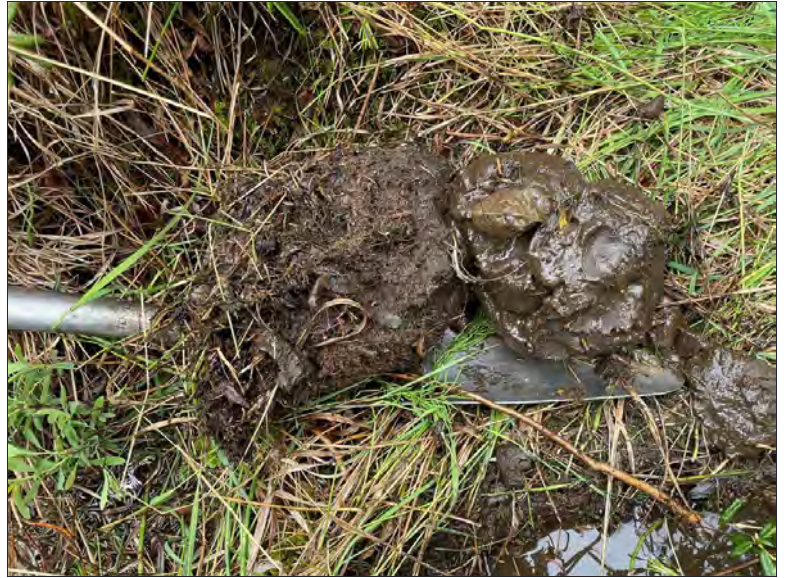
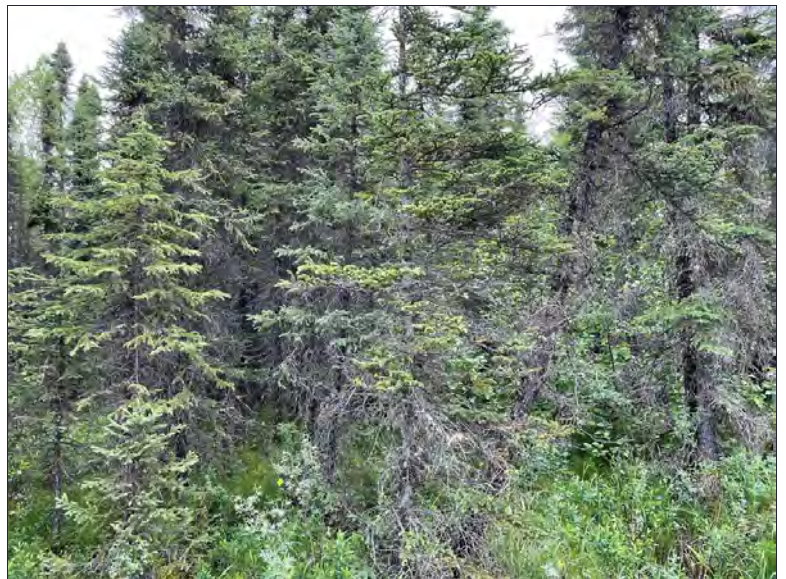
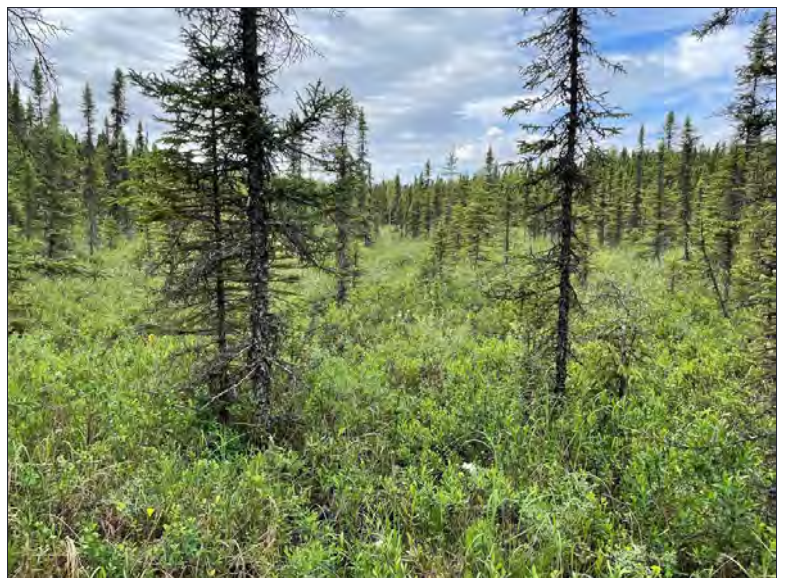
Plot Number	ST009
Wetland Status	Wetland
Plot Type	WD
Plot Date	6/9/2022
NWI Classification	PSS1/4C
HGM	Slope
Latitude (DD)	61.6173314868
Longitude (DD)	-149.597285089

Photo Type: Soils

Photo Type: Vegetation

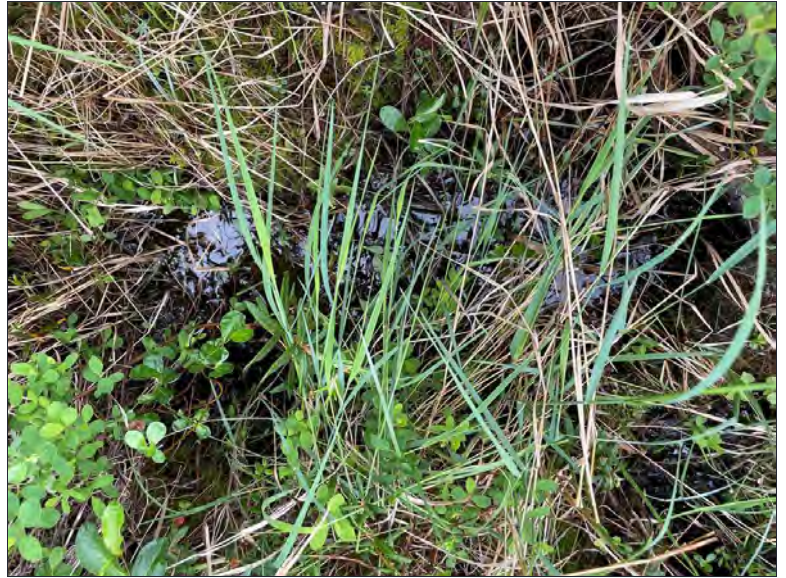
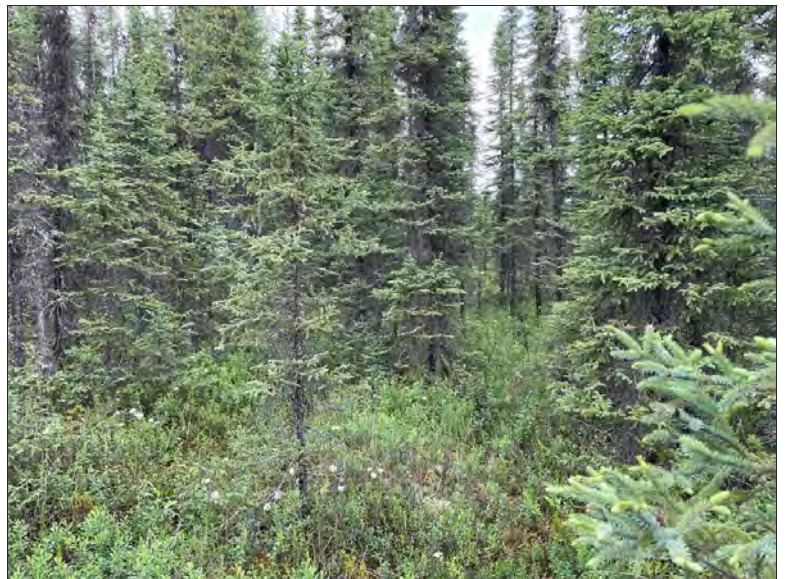
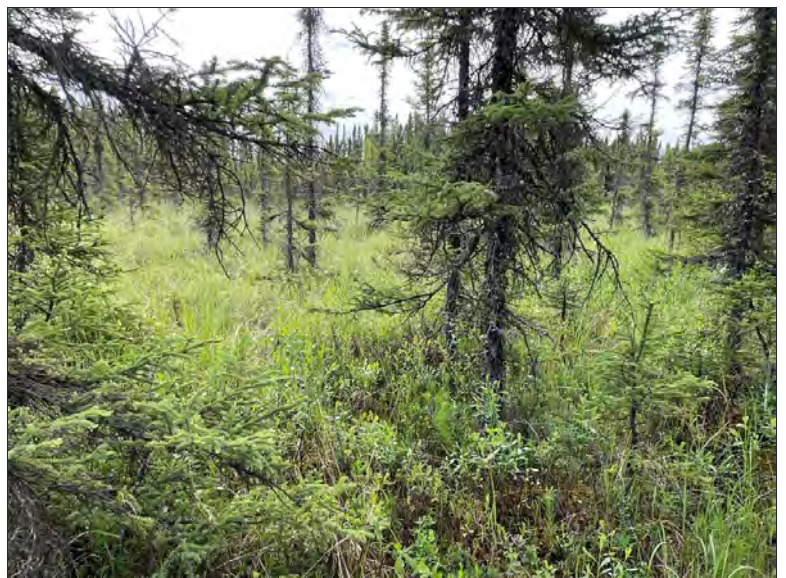
Plot Number	ST010
Wetland Status	Wetland
Plot Type	FVP
Plot Date	6/9/2022
NWI Classification	PSS4/1C
HGM	Slope
Latitude (DD)	61.6173631984
Longitude (DD)	-149.598378318

Photo Type: Hydrology

Photo Type: Vegetation

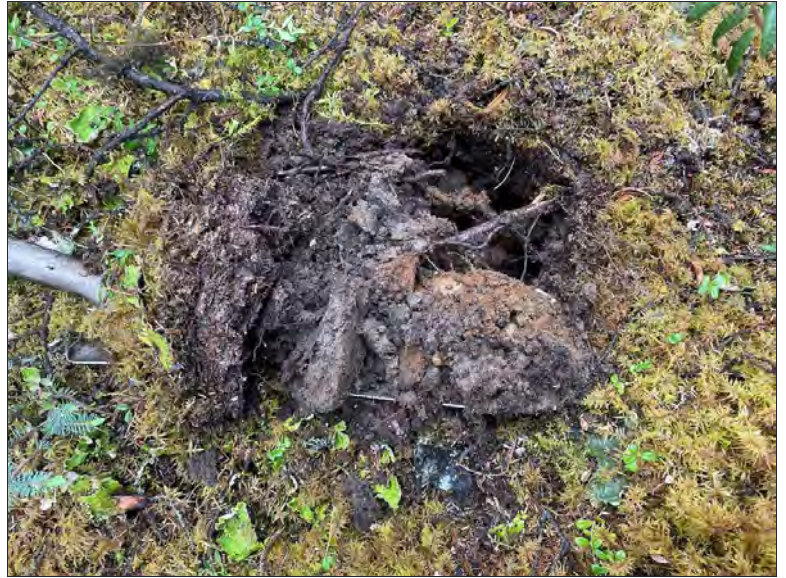
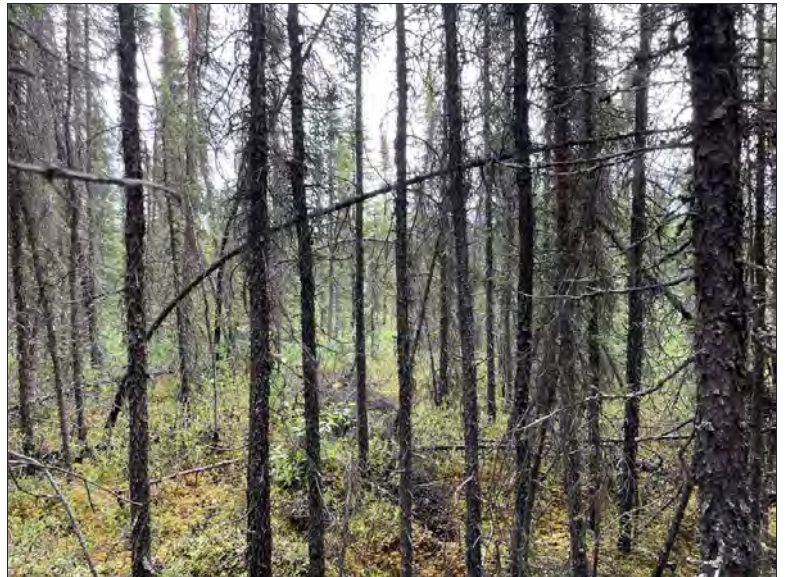
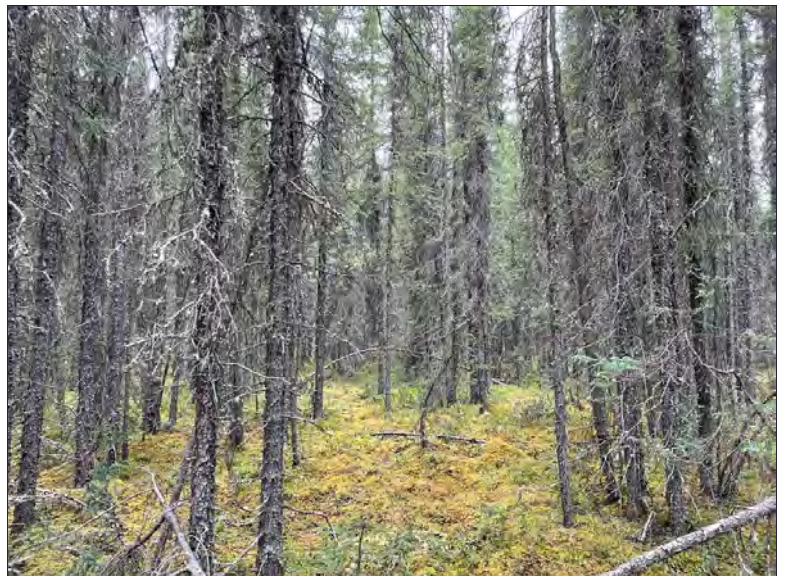
Plot Number	ST011
Wetland Status	Upland
Plot Type	FVP
Plot Date	6/9/2022
NWI Classification	U
HGM	N/A
Latitude (DD)	61.6174135703
Longitude (DD)	-149.598681387

Photo Type: Soils

Photo Type: Vegetation

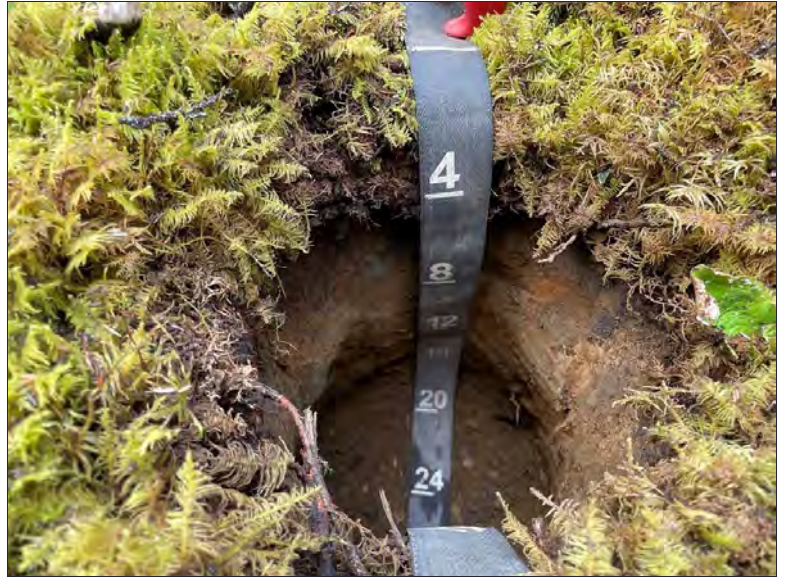
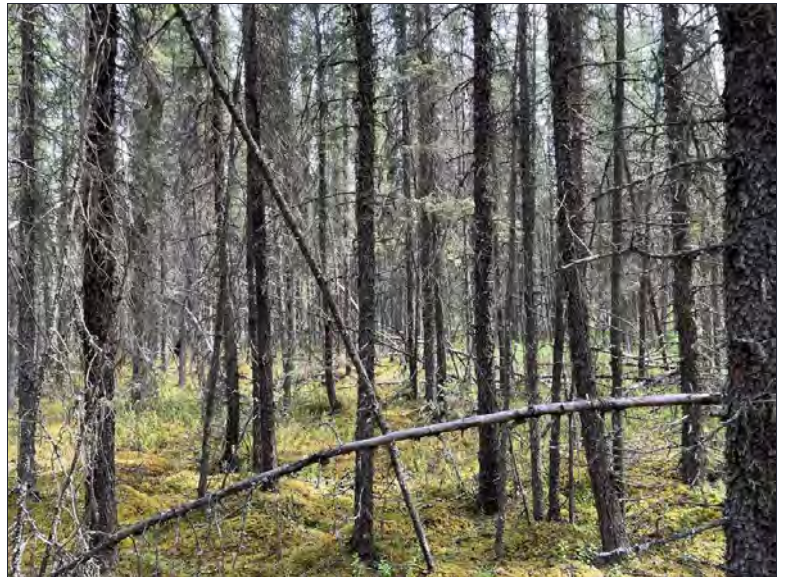
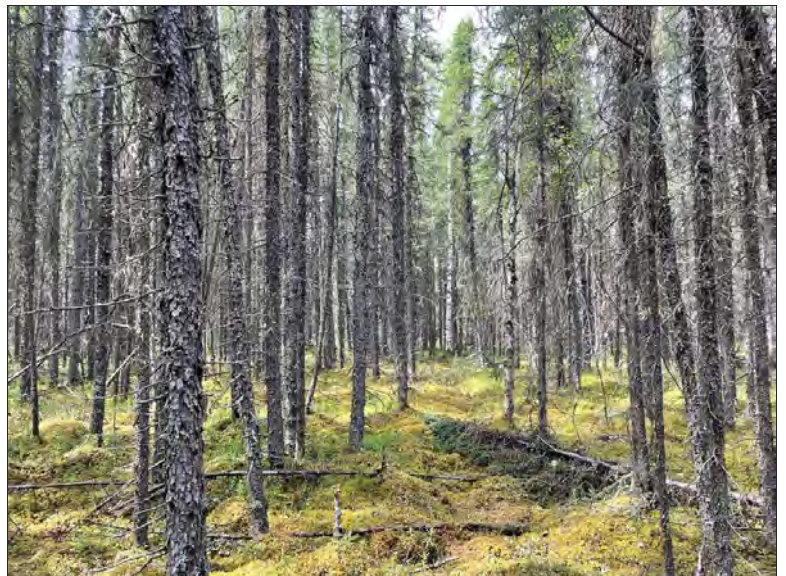
Plot Number	ST012
Wetland Status	Upland
Plot Type	WD
Plot Date	6/9/2022
NWI Classification	U
HGM	N/A
Latitude (DD)	61.6170912466
Longitude (DD)	-149.602652902

Photo Type: Soils

Photo Type: Vegetation

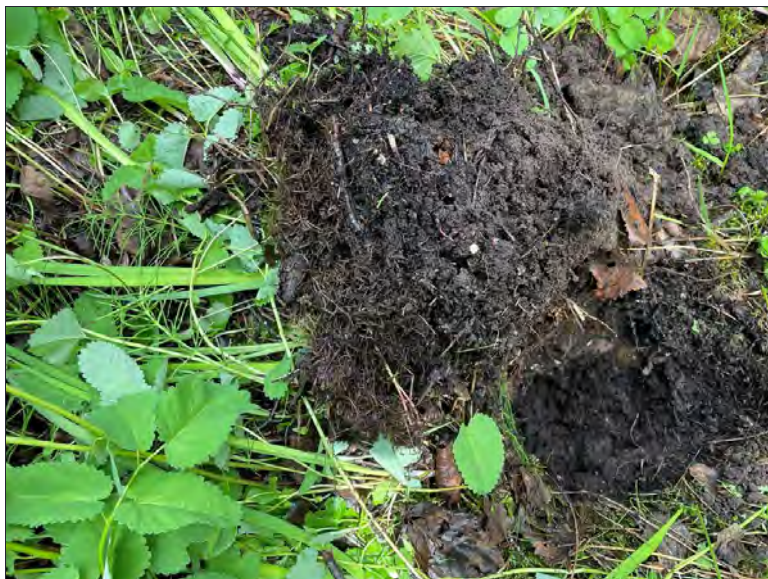
Photo Type: Soils

Direction: NA

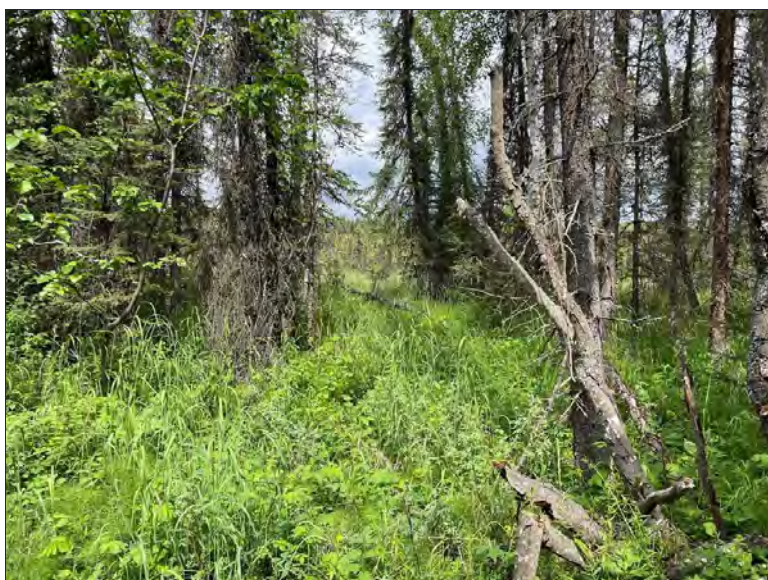
Photo Type: Vegetation

Direction: N

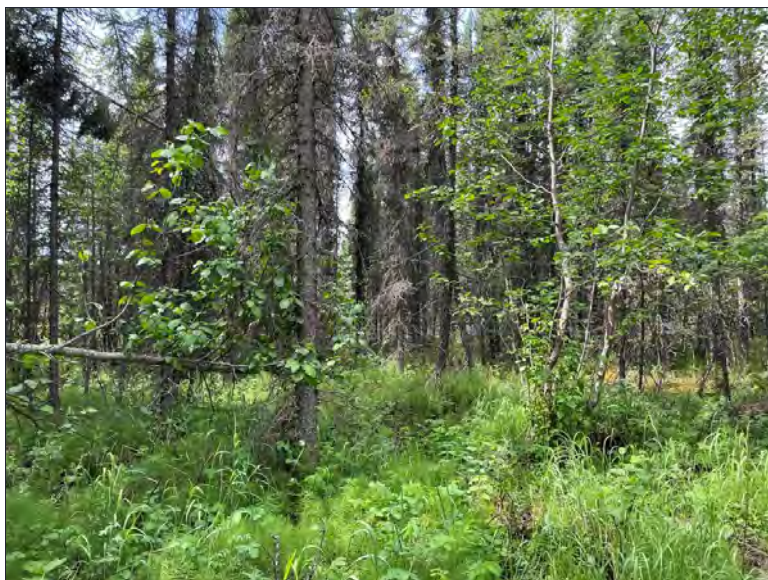
Photo Type: Vegetation

Direction: W

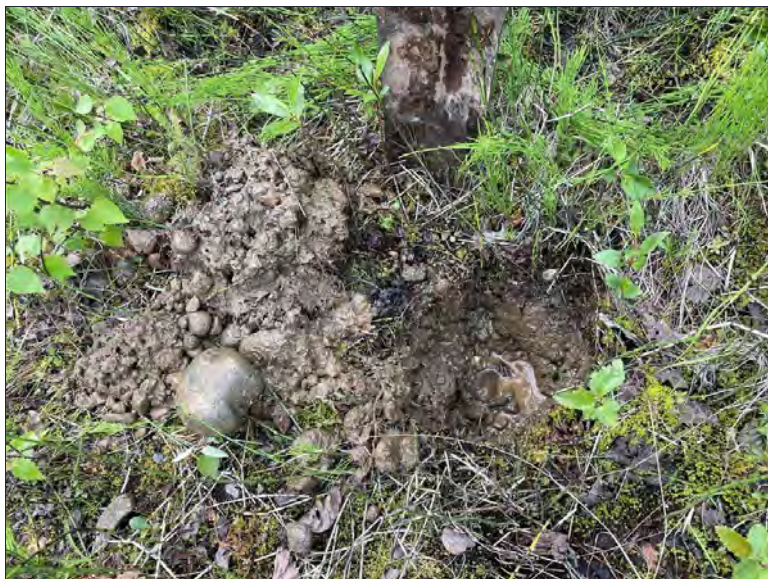
Photo Type: Soils

Direction: NA
