**Wetlands and Waters Delineation  
Report**

**Seldon Road Extension Phase II**

CFHWY00562

August 12, 2022

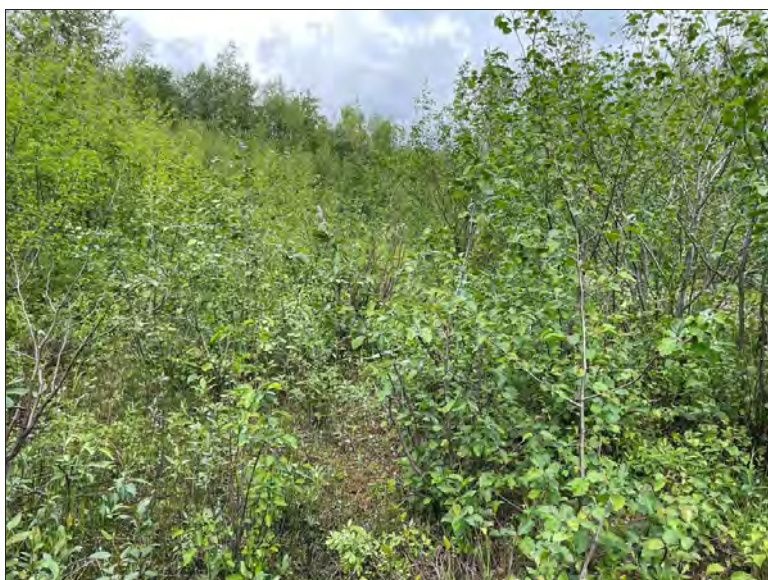
Photo Type: Vegetation

Direction: N

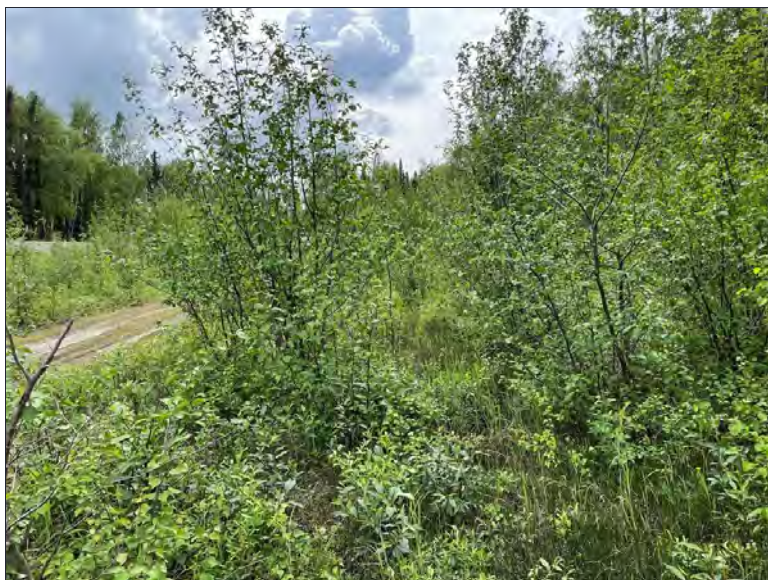
Photo Type: Vegetation

Direction: S

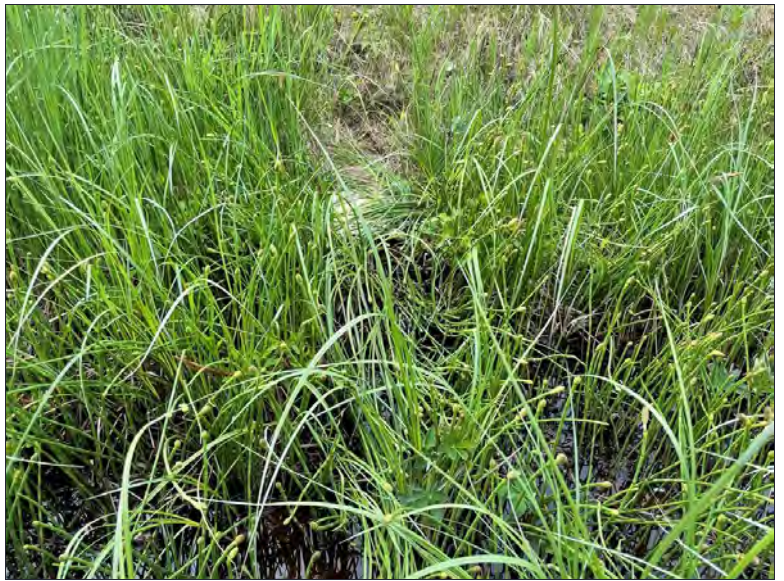
Photo Type: Hydrology

Direction: NA

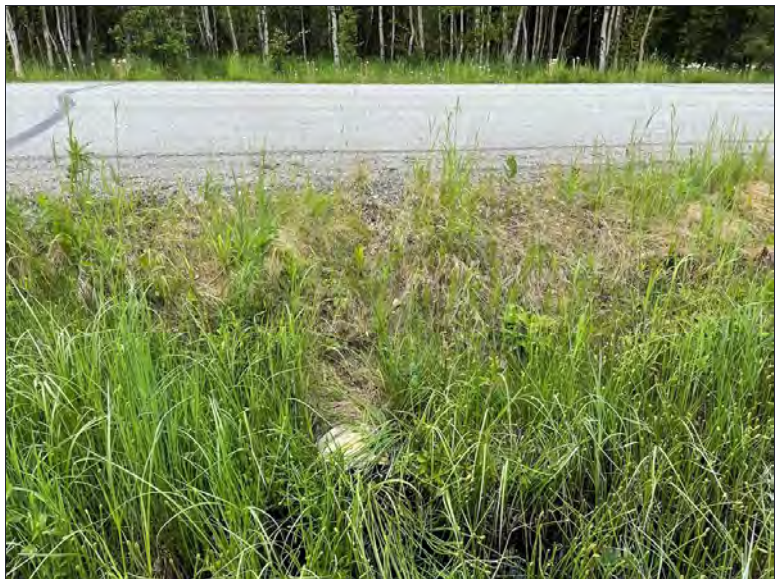
Photo Type: Hydrology

Direction: W

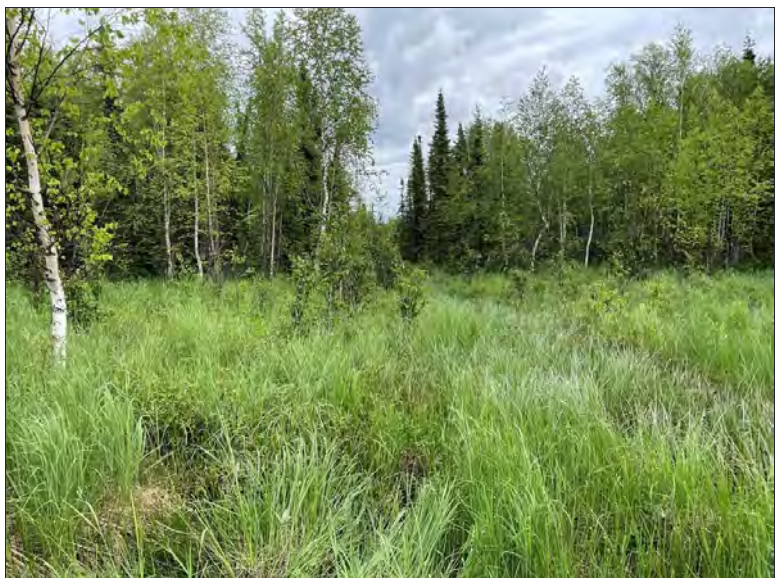
Photo Type: Vegetation

Direction: E

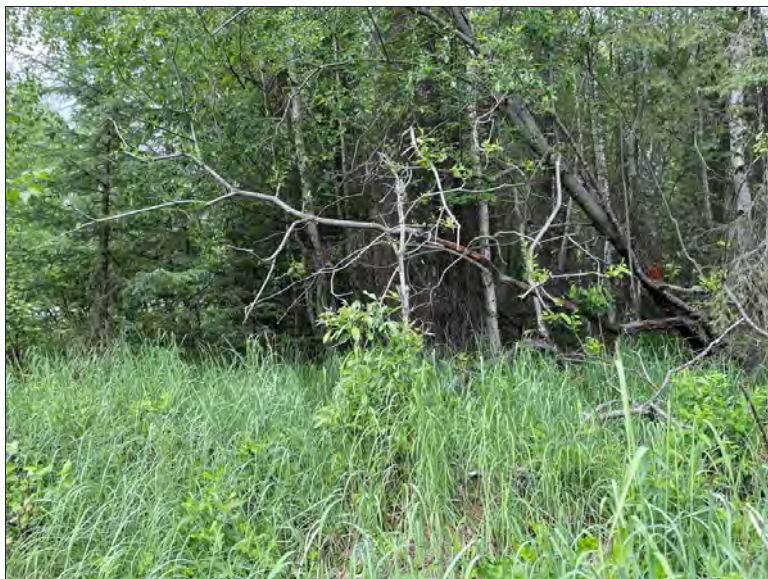
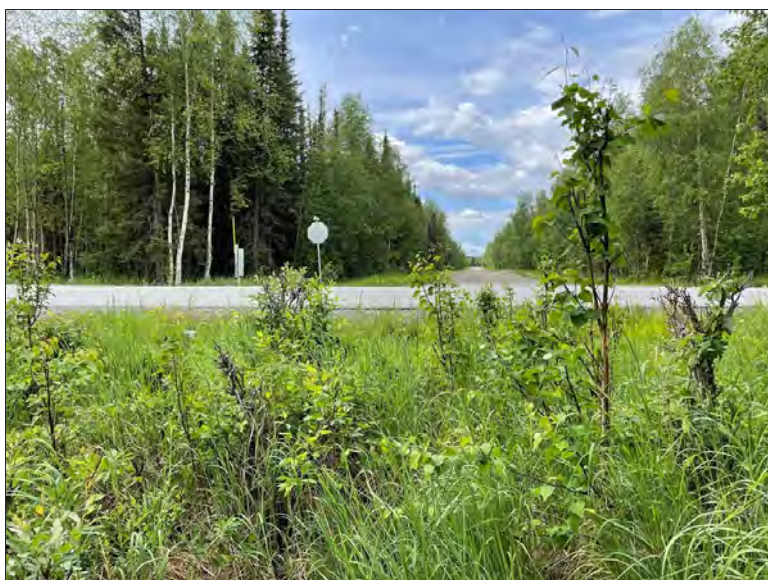
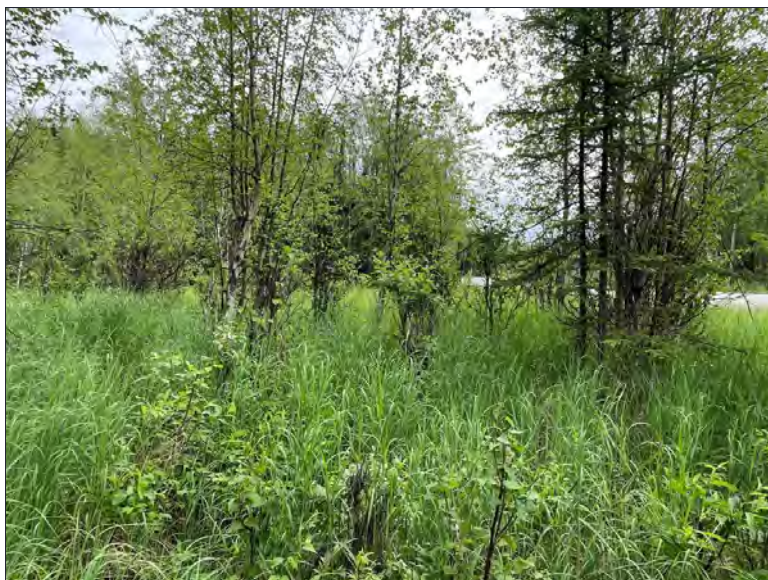
Plot Number	ST016
Wetland Status	Wetland
Plot Type	FVP
Plot Date	6/9/2022
NWI Classification	PSS1/FO1C
HGM	Riverine
Latitude (DD)	61.6193176007
Longitude (DD)	-149.589738094

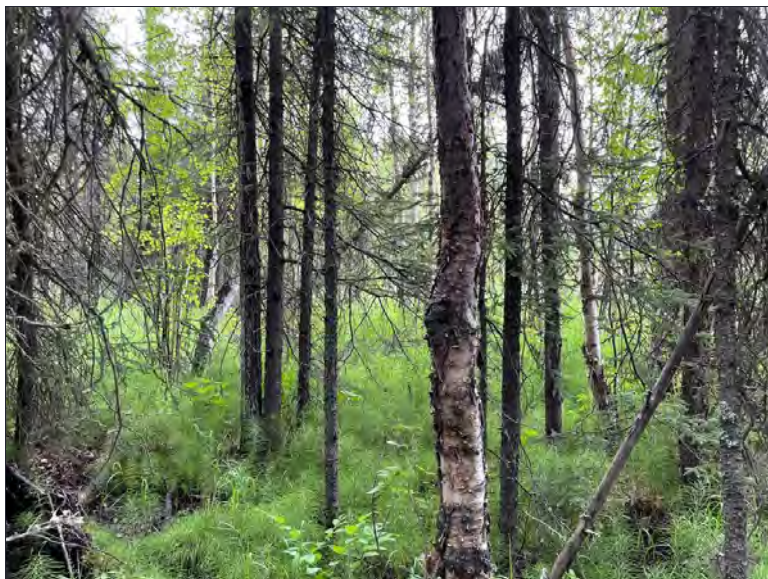
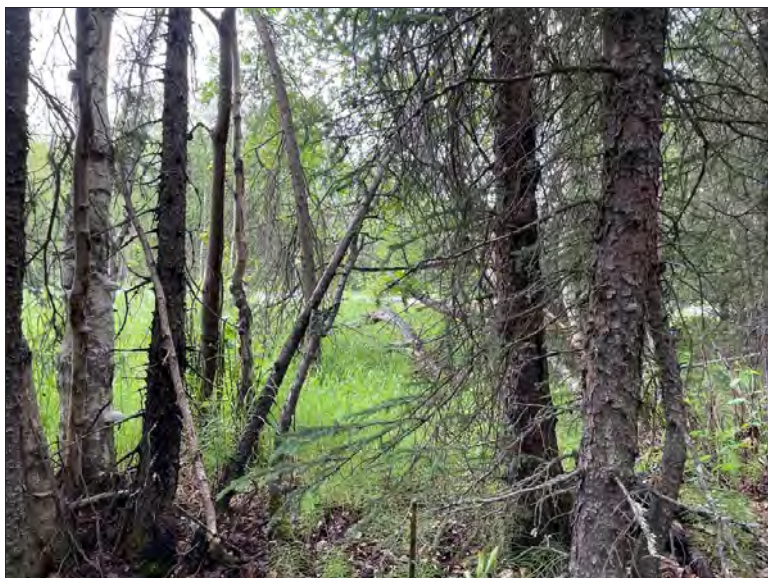
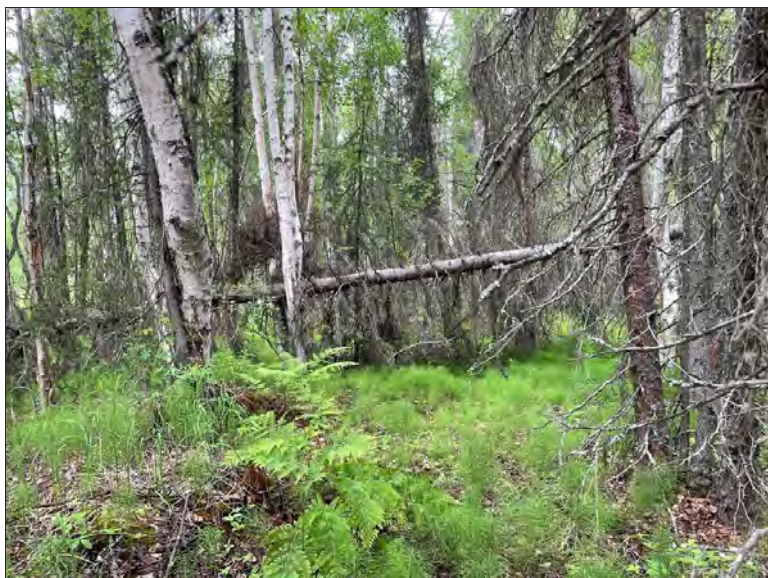
Plot Number	ST017
Wetland Status	Upland
Plot Type	FVP
Plot Date	6/9/2022
NWI Classification	U
HGM	N/A
Latitude (DD)	61.6193920508
Longitude (DD)	-149.589600158

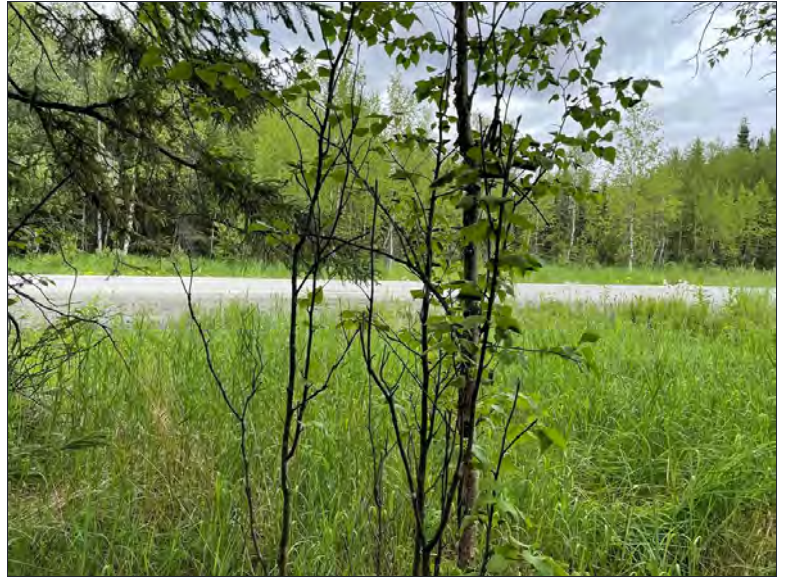
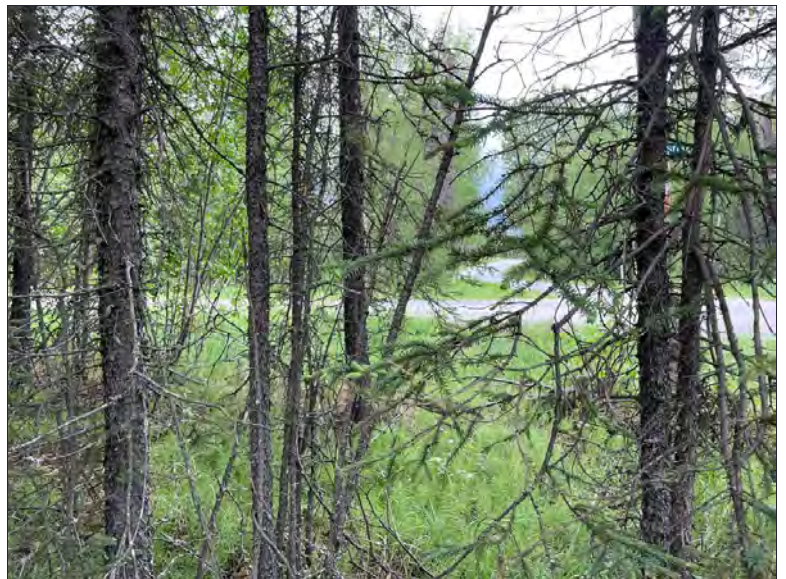
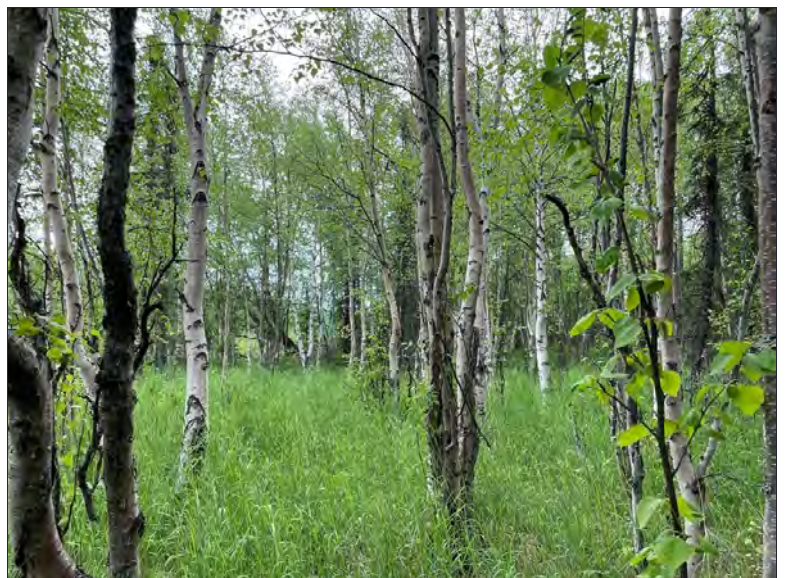
Plot Number	ST018
Wetland Status	Upland
Plot Type	FVP
Plot Date	6/9/2022
NWI Classification	U
HGM	N/A
Latitude (DD)	61.6191942133
Longitude (DD)	-149.590183315

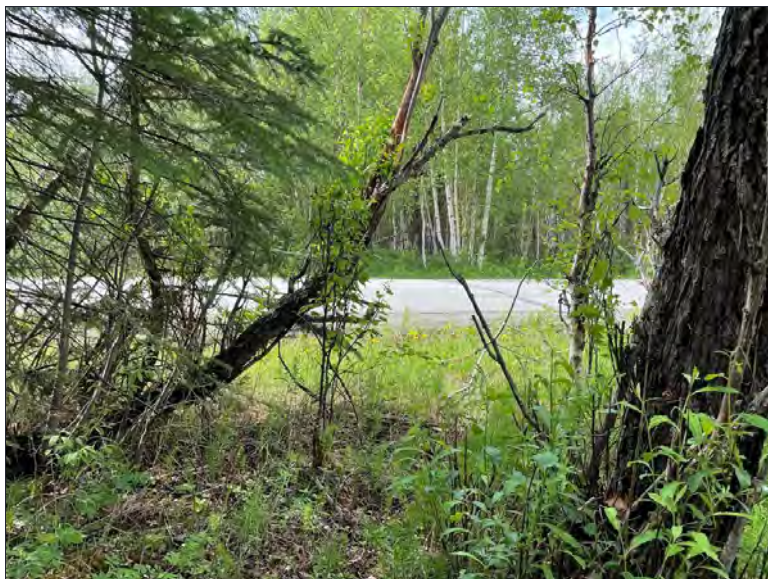
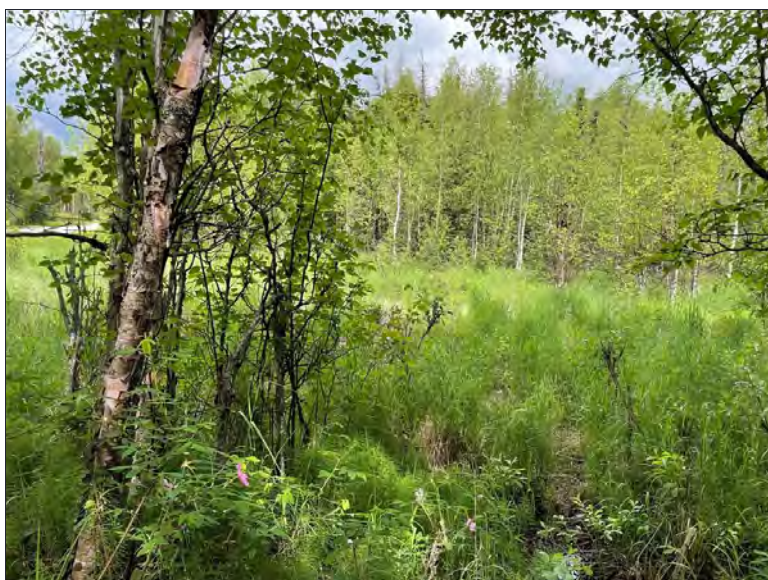
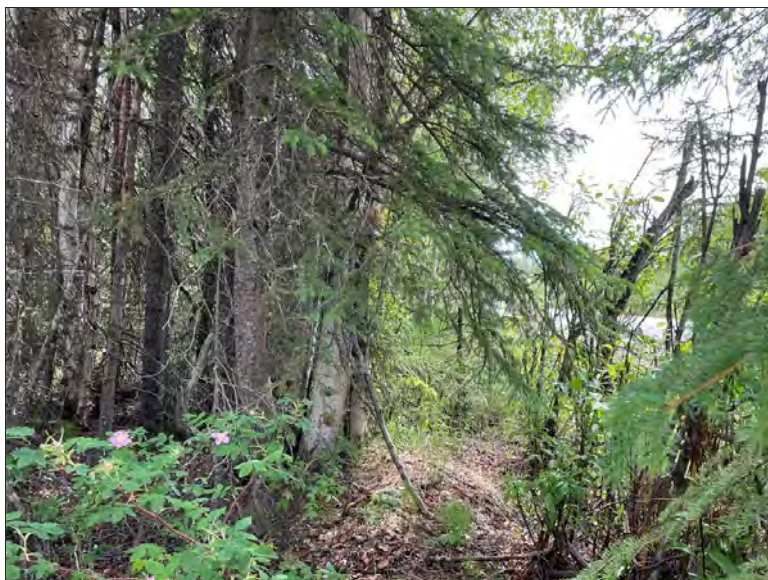
Plot Number	ST019
Wetland Status	Upland
Plot Type	FVP
Plot Date	6/9/2022
NWI Classification	U
HGM	N/A
Latitude (DD)	61.6189271062
Longitude (DD)	-149.58956437

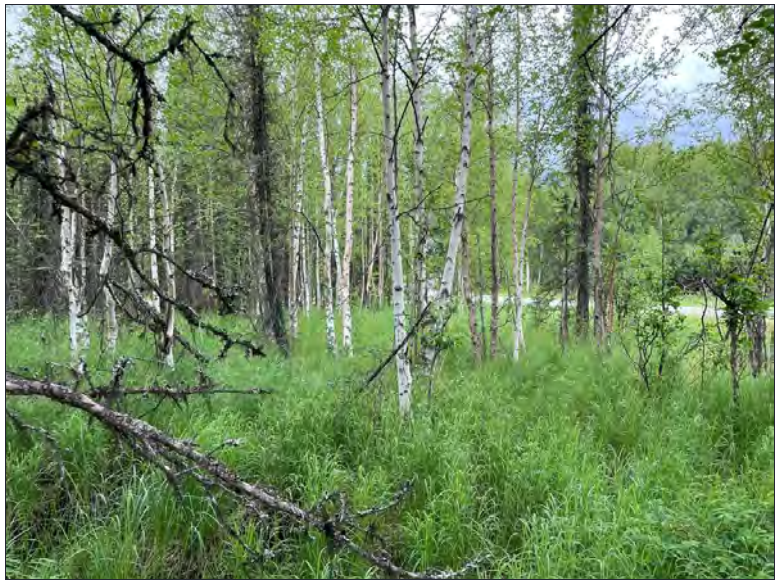
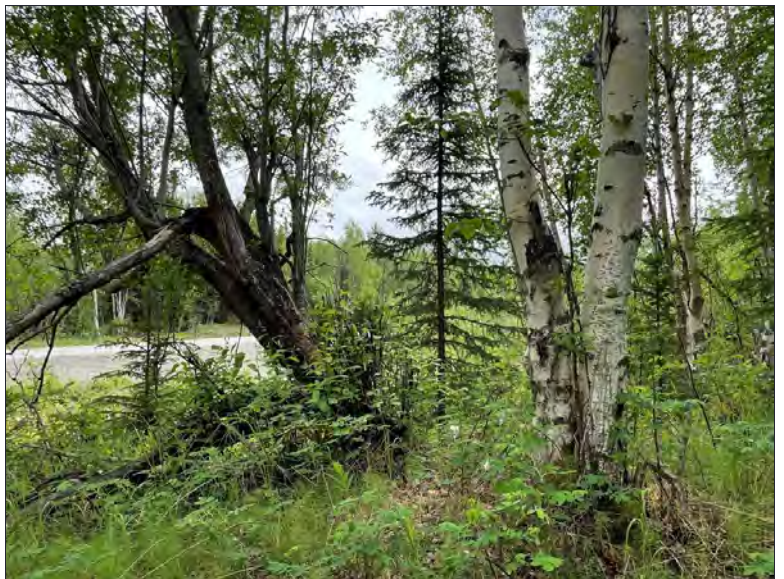
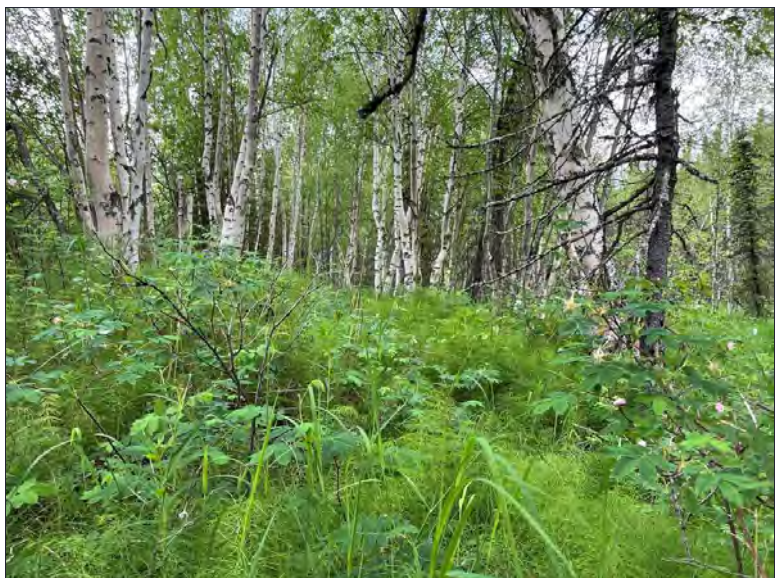
Plot Number	ST020
Wetland Status	Upland
Plot Type	FVP
Plot Date	6/9/2022
NWI Classification	U
HGM	N/A
Latitude (DD)	61.6138913815
Longitude (DD)	-149.611601005

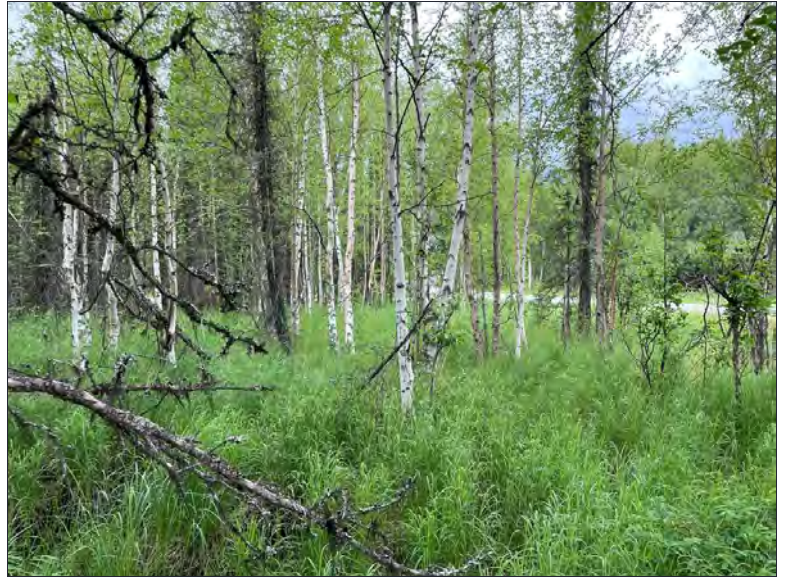
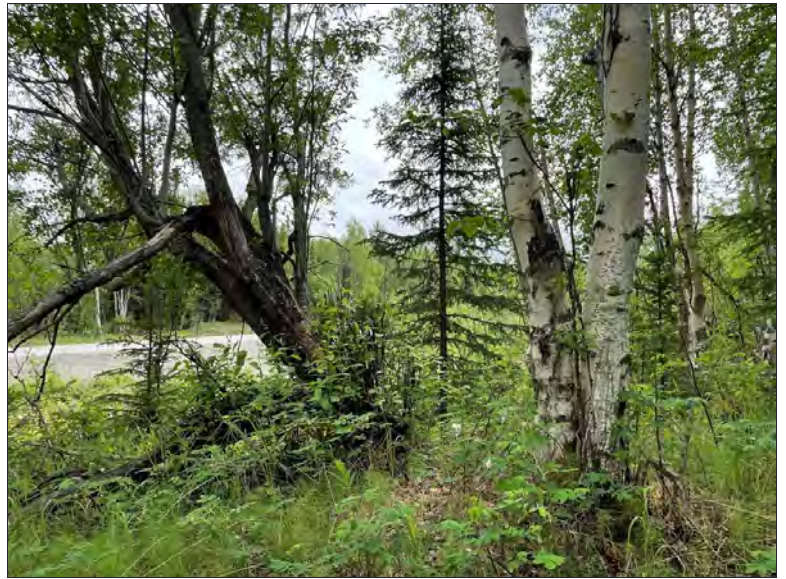
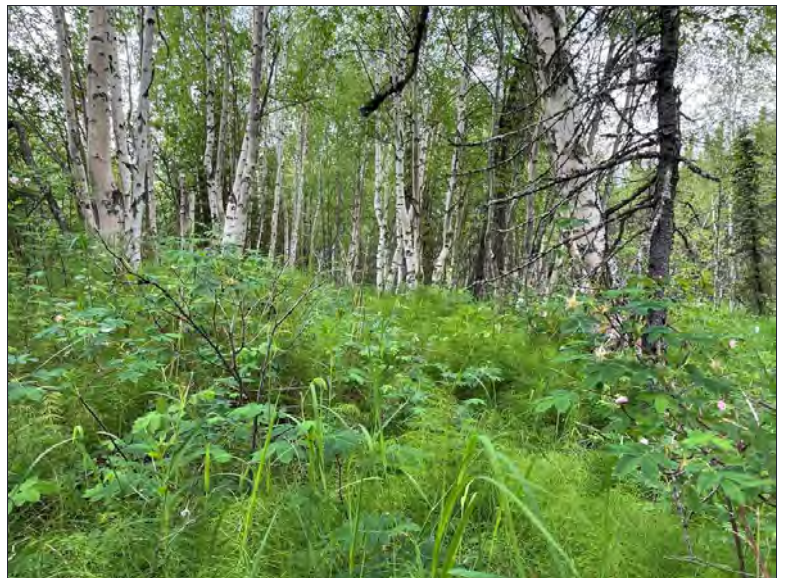
Plot Number	ST020
Wetland Status	Upland
Plot Type	FVP
Plot Date	6/9/2022
NWI Classification	U
HGM	N/A
Latitude (DD)	61.6189182507
Longitude (DD)	-149.590088282

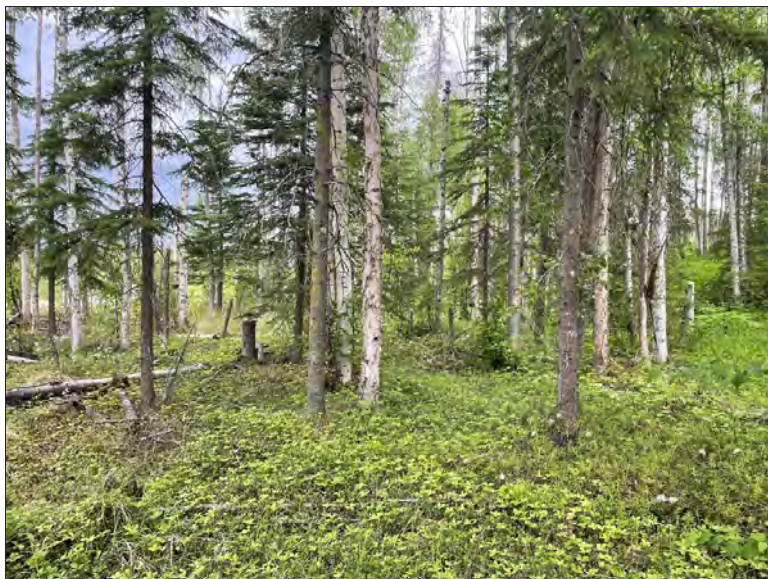
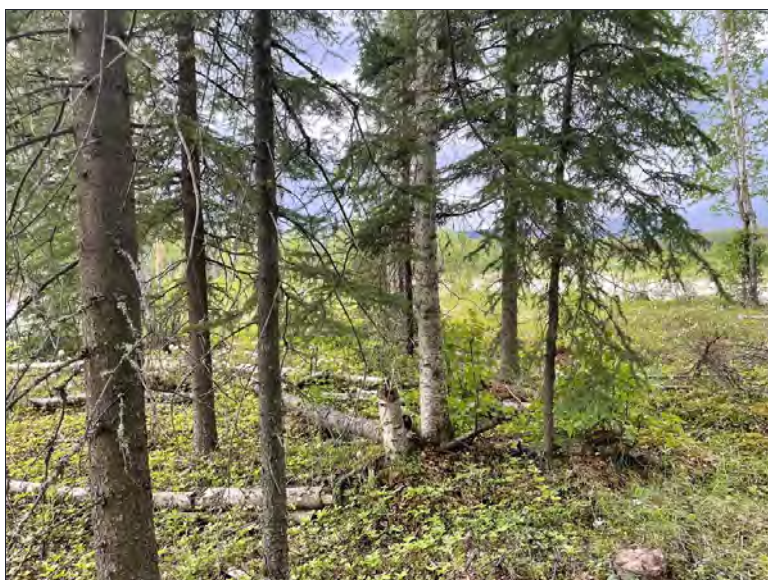
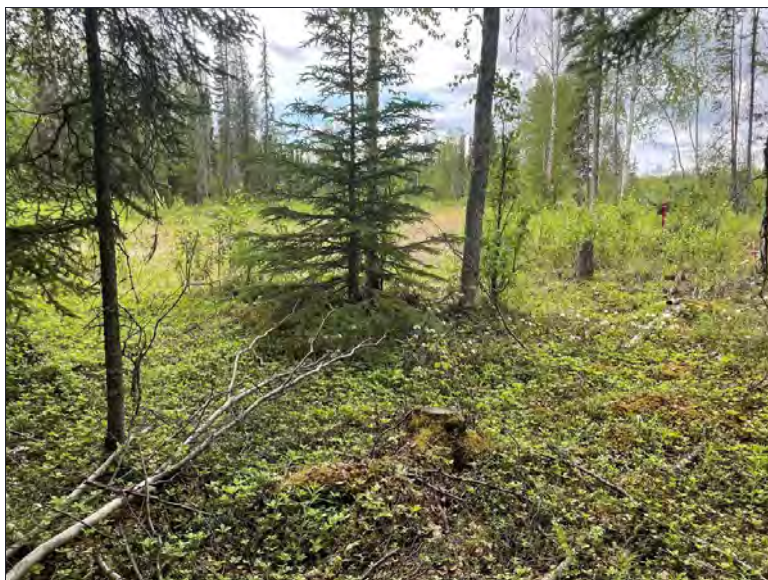
Plot Number	ST022
Wetland Status	Upland
Plot Type	FVP
Plot Date	6/9/2022
NWI Classification	U
HGM	N/A
Latitude (DD)	61.6135213392
Longitude (DD)	-149.618223559

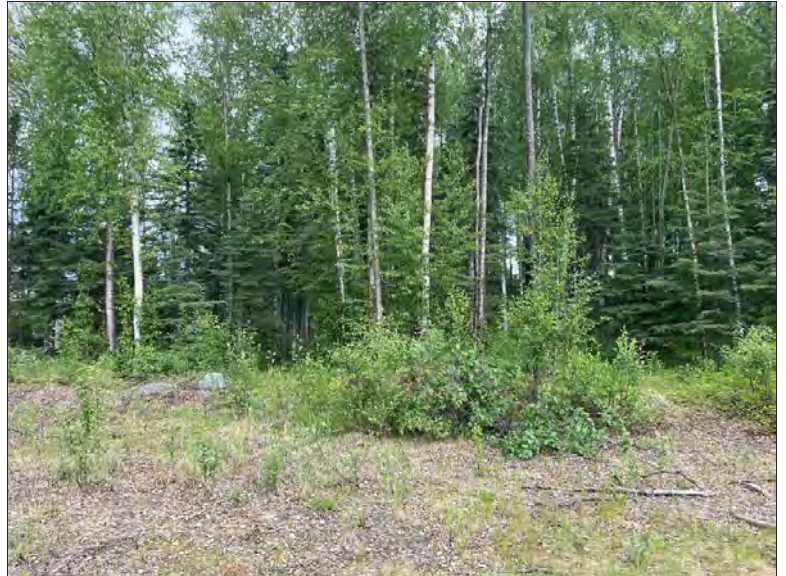
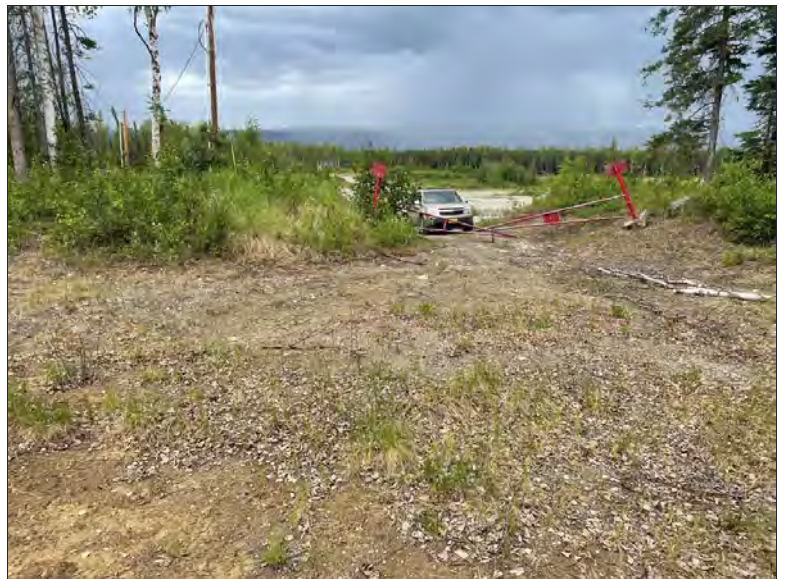
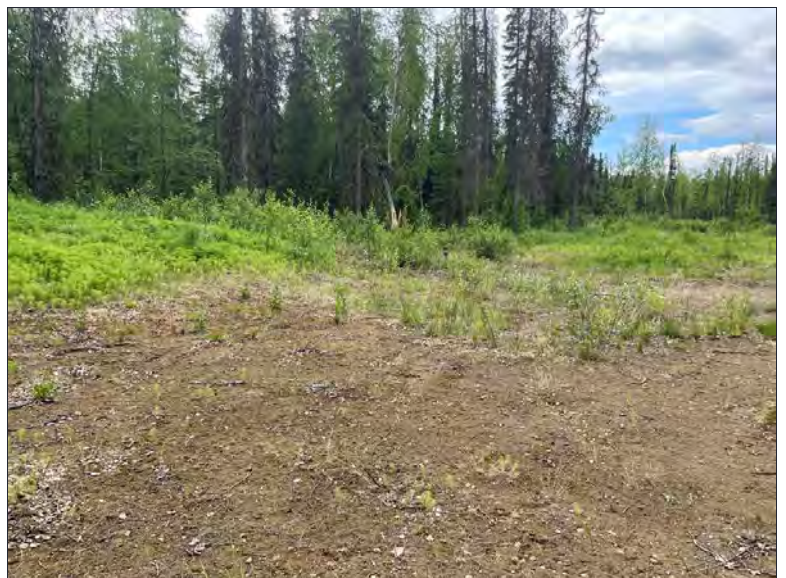
Plot Number	ST023
Wetland Status	Upland
Plot Type	FVP
Plot Date	6/9/2022
NWI Classification	U
HGM	N/A
Latitude (DD)	61.6134644957
Longitude (DD)	-149.618587645

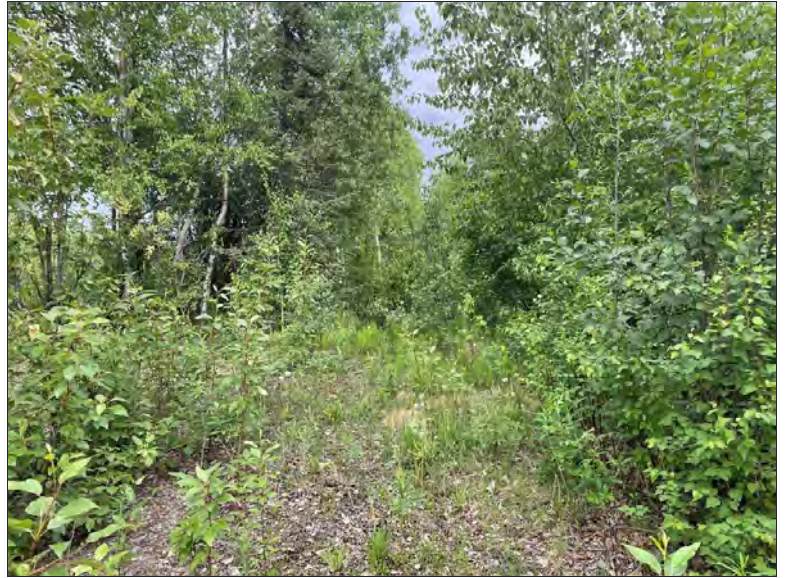
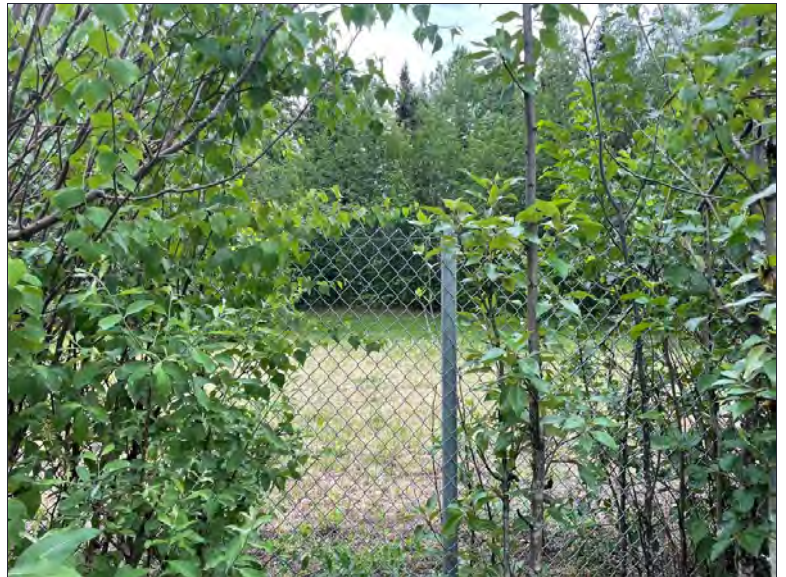
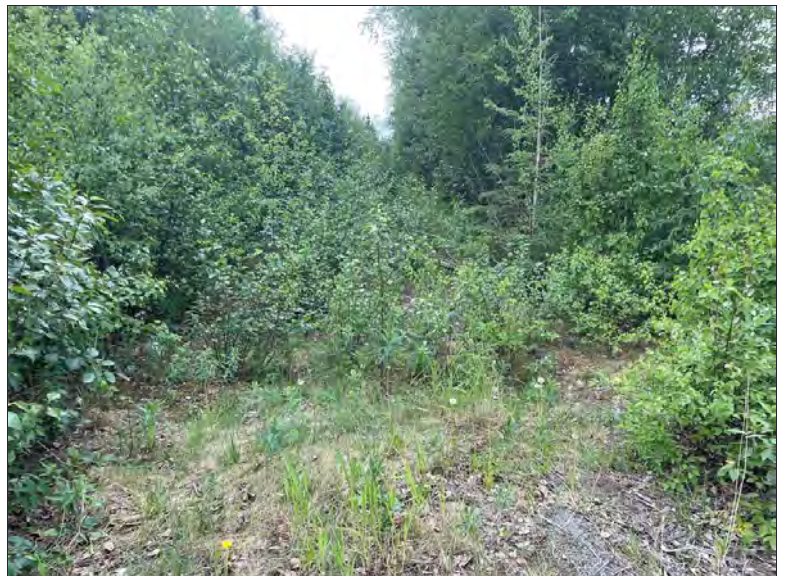
Plot Number	ST024
Wetland Status	Upland
Plot Type	FVP
Plot Date	6/9/2022
NWI Classification	U
HGM	N/A
Latitude (DD)	61.6120788323
Longitude (DD)	-149.622912781

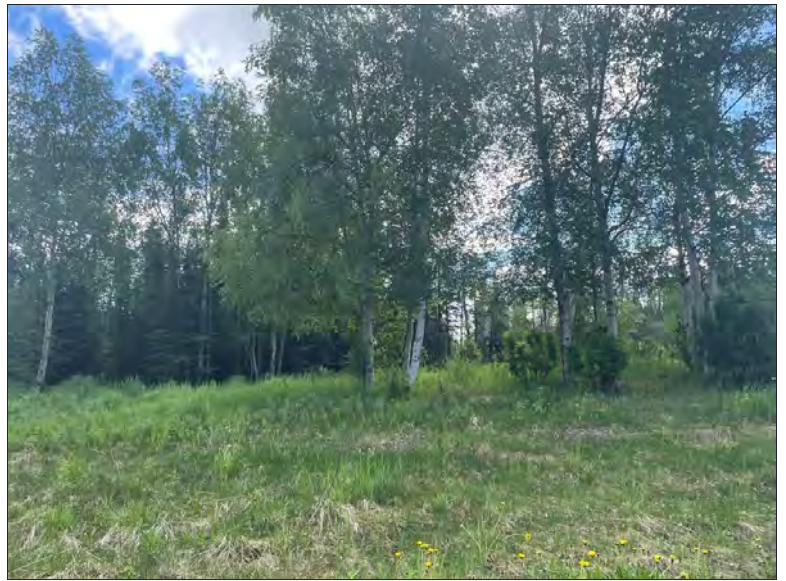
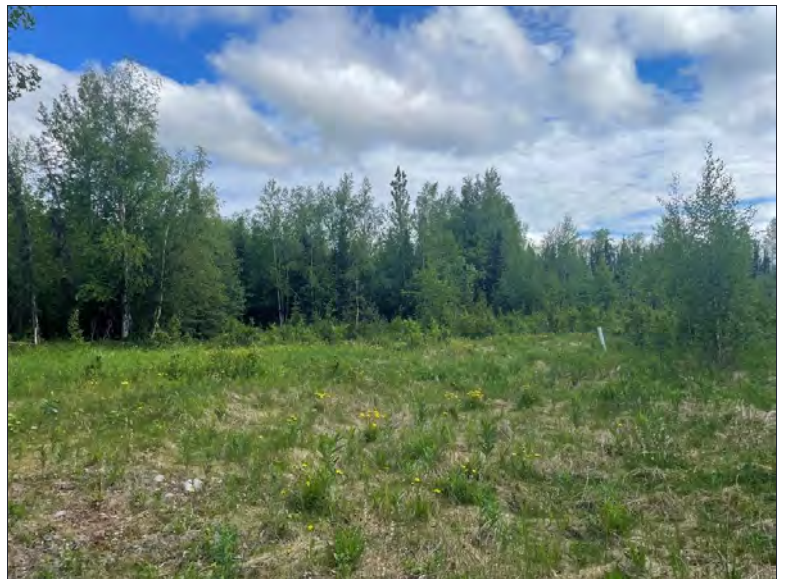
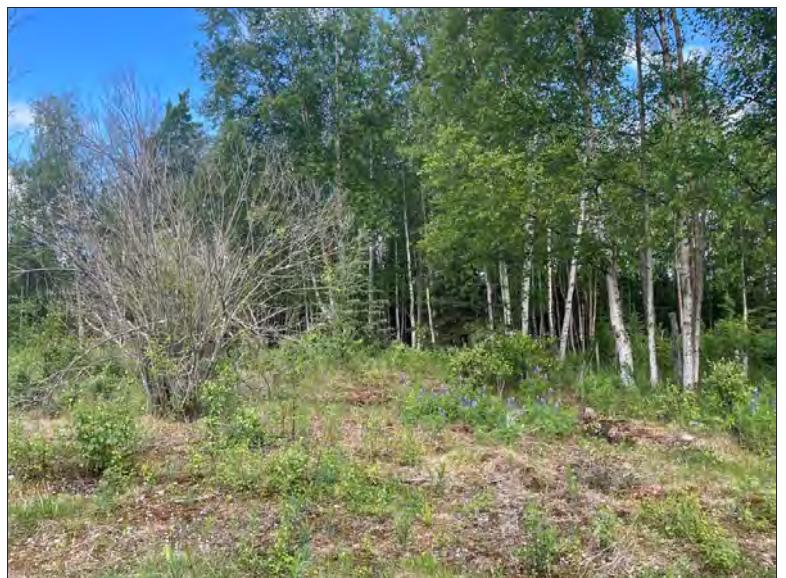
Plot Number	ST025
Wetland Status	Upland
Plot Type	FVP
Plot Date	6/10/2022
NWI Classification	U
HGM	N/A
Latitude (DD)	61.6177889983
Longitude (DD)	-149.588328109

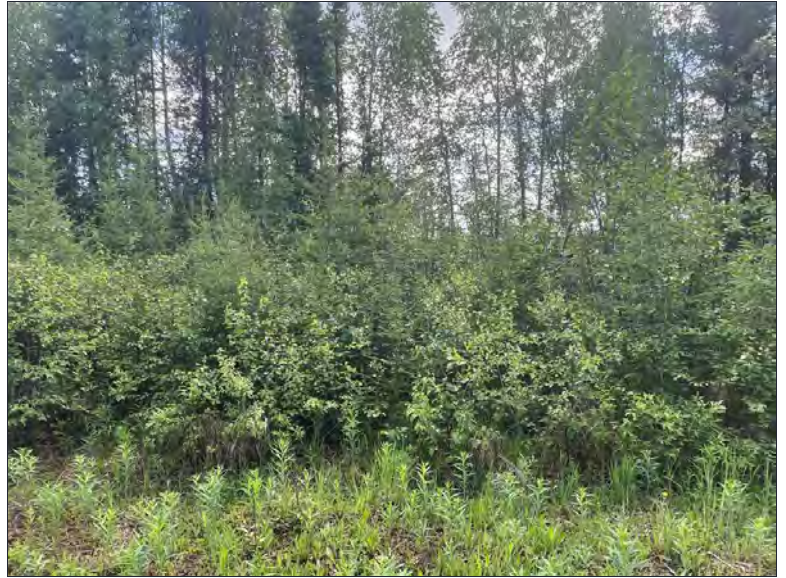
Plot Number	ST026
Wetland Status	Upland
Plot Type	FVP
Plot Date	6/10/2022
NWI Classification	U
HGM	N/A
Latitude (DD)	61.6179082931
Longitude (DD)	-149.587090345

Photo Type: Vegetation

Direction: E

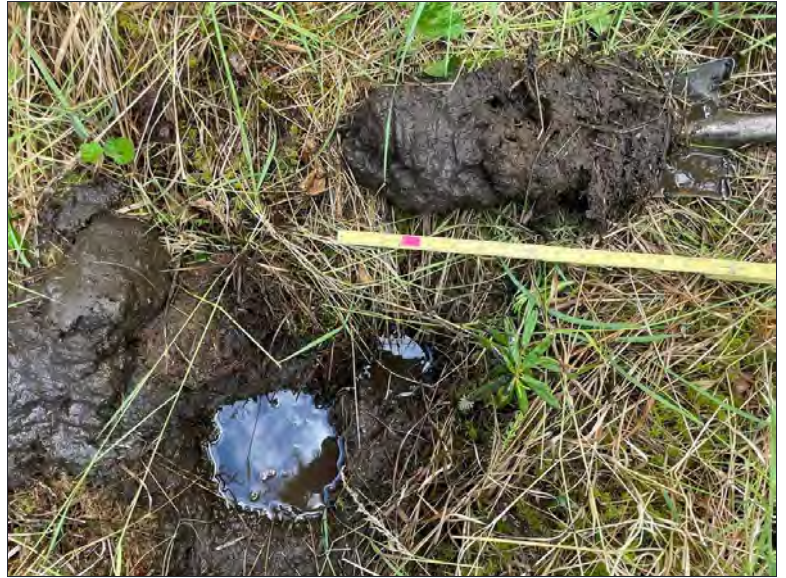
Plot Number	ST027
Wetland Status	Wetland
Plot Type	WD
Plot Date	6/10/2022
NWI Classification	PSS4/EM1C
HGM	Slope
Latitude (DD)	61.6180067072
Longitude (DD)	-149.585068083

Photo Type: Soils

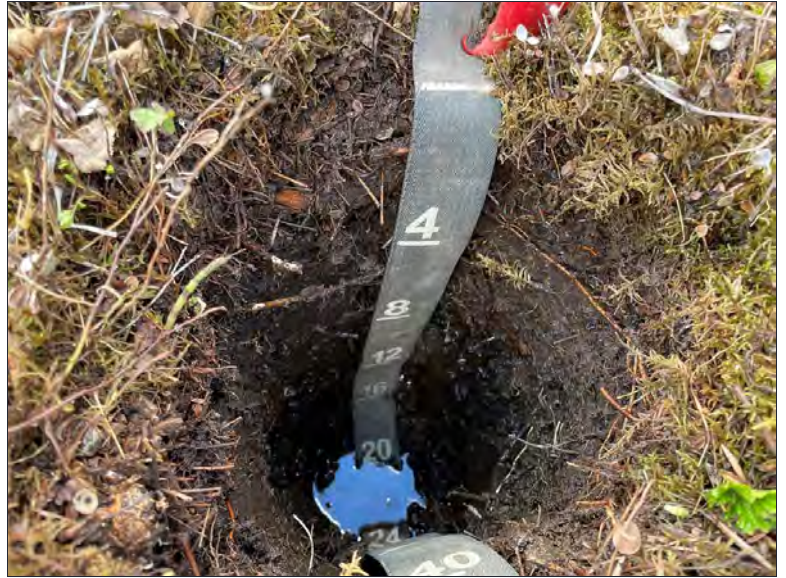
Plot Number	ST028
Wetland Status	Wetland
Plot Type	WD
Plot Date	6/10/2022
NWI Classification	PSS1B
HGM	Slope
Latitude (DD)	61.6179034983
Longitude (DD)	-149.585234939

Photo Type: Soils

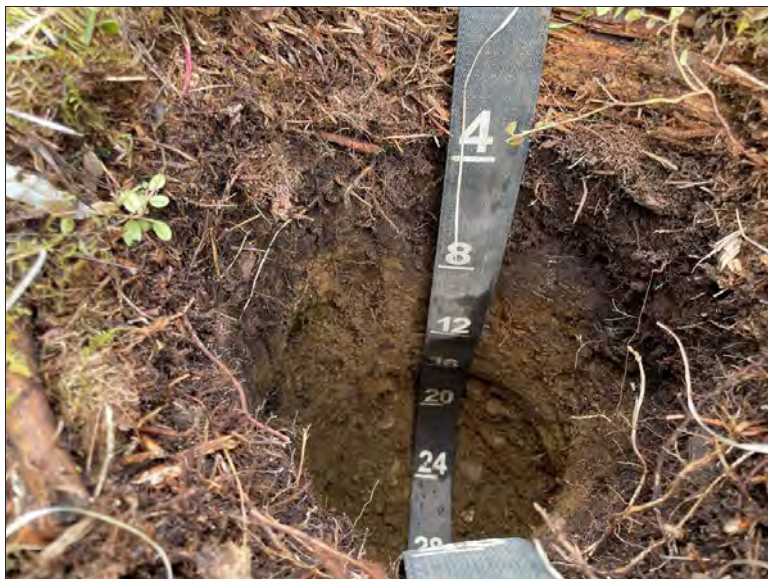
Plot Number	ST029
Wetland Status	Upland
Plot Type	WD
Plot Date	6/10/2022
NWI Classification	U
HGM	N/A
Latitude (DD)	61.6176703561
Longitude (DD)	-149.585404785

Photo Type: Soils

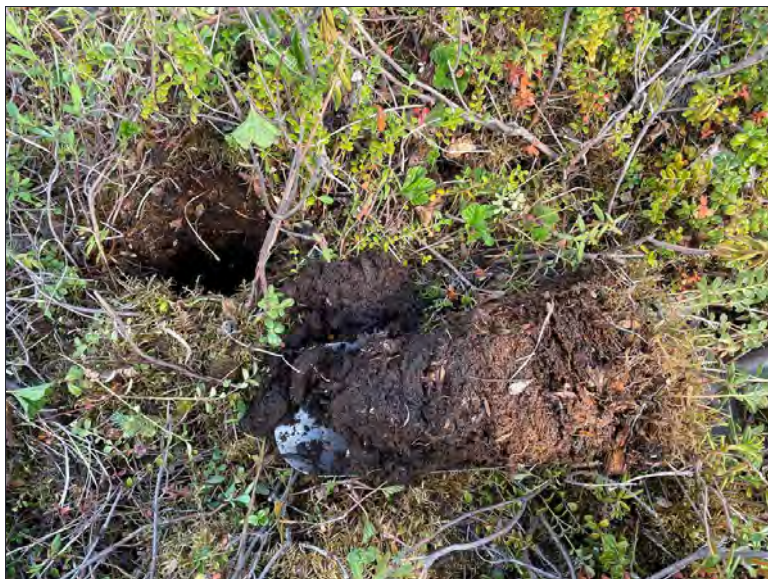
Plot Number	ST030
Wetland Status	Wetland
Plot Type	FVP
Plot Date	6/10/2022
NWI Classification	PSS1C
HGM	Slope
Latitude (DD)	61.6177549146
Longitude (DD)	-149.584589583

Photo Type: Soils

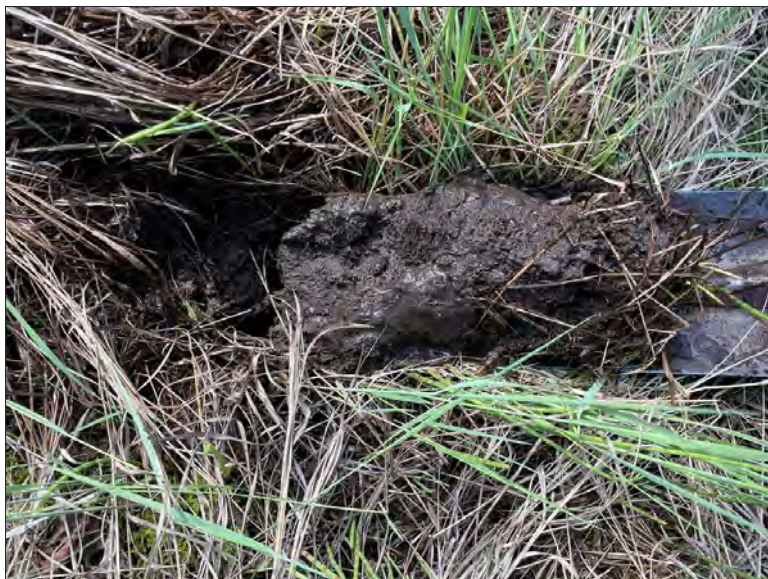
Plot Number	ST031
Wetland Status	Wetland
Plot Type	FVP
Plot Date	6/10/2022
NWI Classification	PEM1C
HGM	Slope
Latitude (DD)	61.6177694599
Longitude (DD)	-149.584070883

Photo Type: Soils

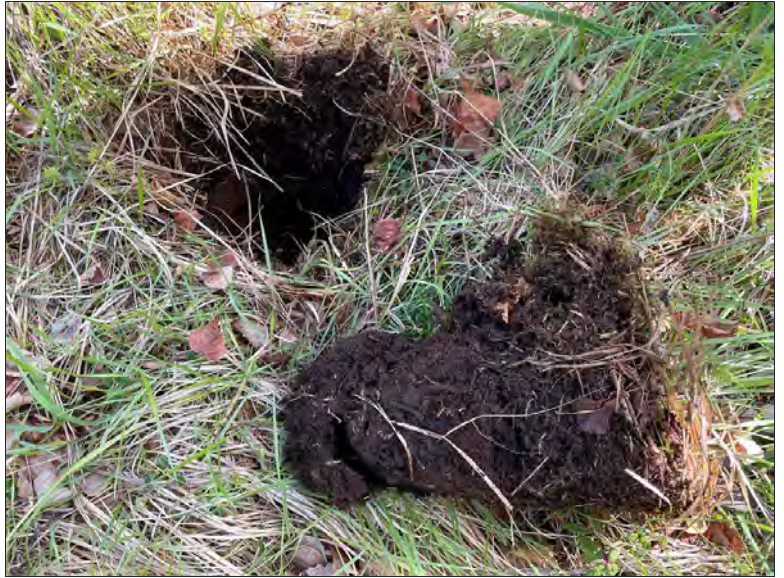
Plot Number	ST032
Wetland Status	Upland
Plot Type	FVP
Plot Date	6/10/2022
NWI Classification	U
HGM	N/A
Latitude (DD)	61.6179375685
Longitude (DD)	-149.583481416

Photo Type: Soils

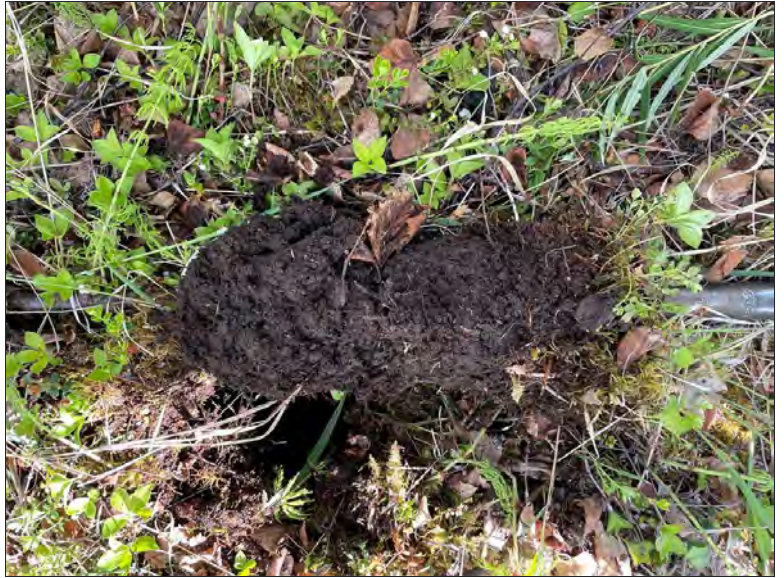
Plot Number	ST033
Wetland Status	Upland
Plot Type	FVP
Plot Date	6/10/2022
NWI Classification	U
HGM	N/A
Latitude (DD)	61.6180695903
Longitude (DD)	-149.582400259

Photo Type: Soils

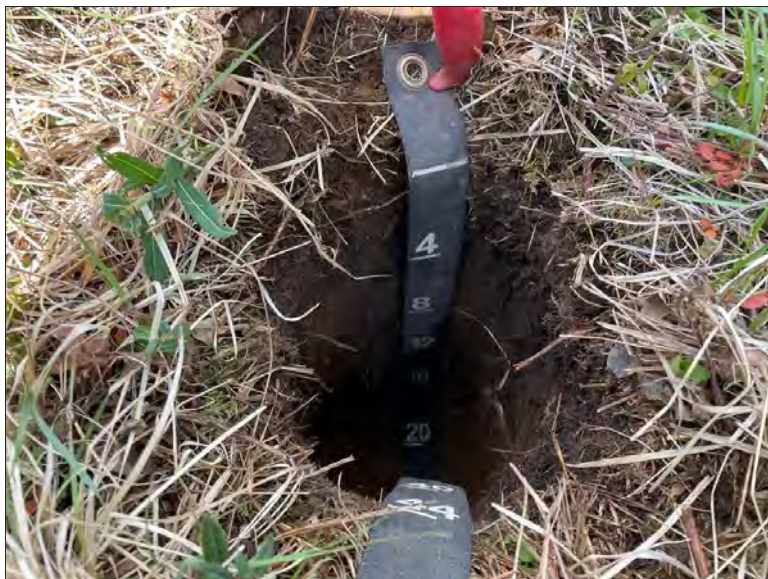
Plot Number	ST034
Wetland Status	Upland
Plot Type	WD
Plot Date	6/10/2022
NWI Classification	U
HGM	N/A
Latitude (DD)	61.6185314337
Longitude (DD)	-149.580182032

Photo Type: Soils

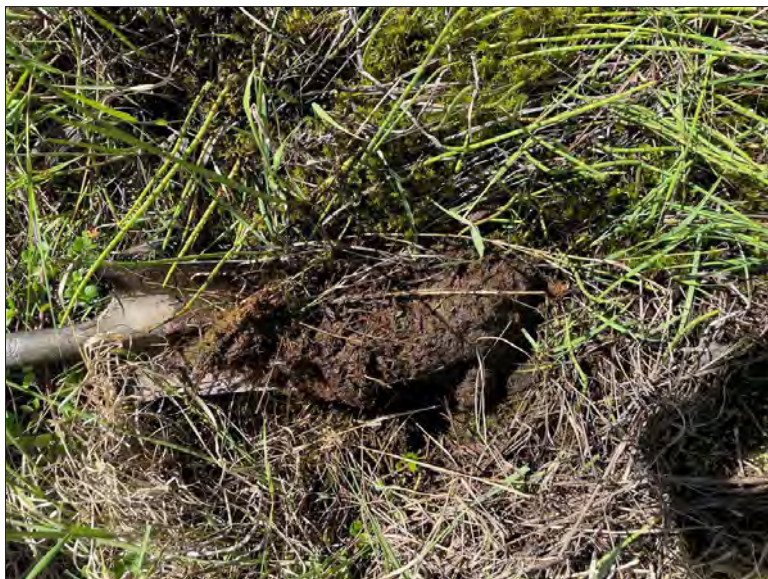
Plot Number	ST035
Wetland Status	Wetland
Plot Type	FVP
Plot Date	6/10/2022
NWI Classification	PEM1/SS1C
HGM	Slope
Latitude (DD)	61.6186480754
Longitude (DD)	-149.58017876

Photo Type: Soils

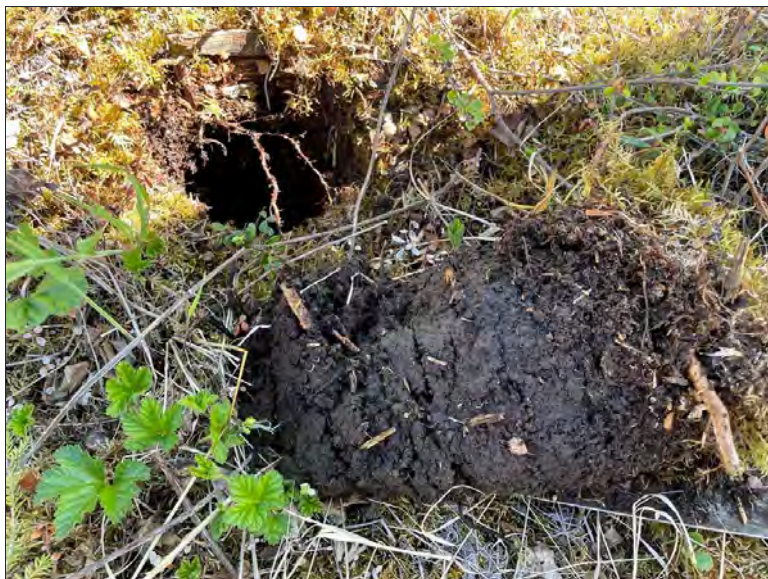
Plot Number	ST037
Wetland Status	Upland
Plot Type	FVP
Plot Date	6/10/2022
NWI Classification	U
HGM	N/A
Latitude (DD)	61.6183864204
Longitude (DD)	-149.577605219

Photo Type: Soils

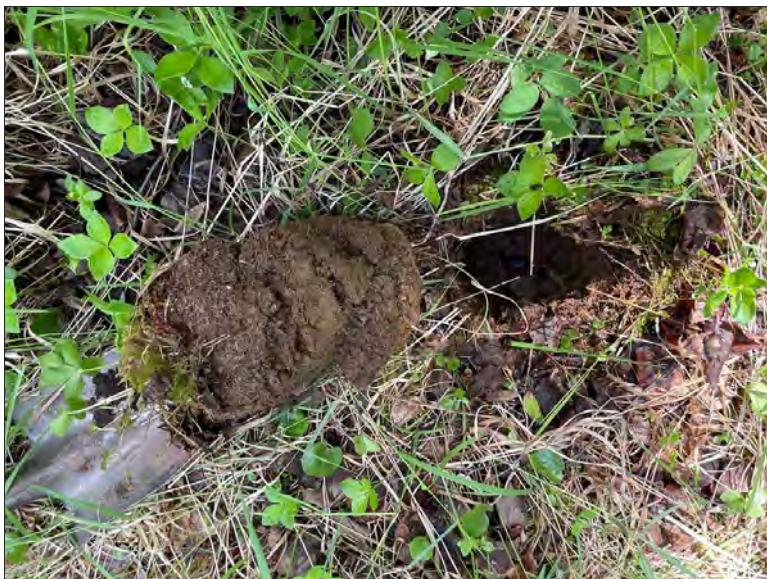
Plot Number	ST038
Wetland Status	Upland
Plot Type	FVP
Plot Date	6/10/2022
NWI Classification	U
HGM	N/A
Latitude (DD)	61.617268243
Longitude (DD)	-149.570191441

Photo Type: Soils

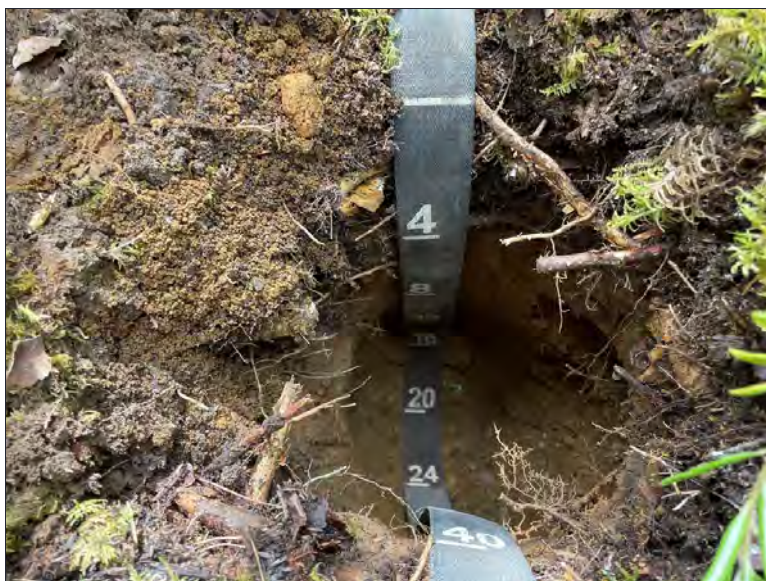
Plot Number	ST039
Wetland Status	Upland
Plot Type	WD
Plot Date	6/10/2022
NWI Classification	U
HGM	N/A
Latitude (DD)	61.6175786055
Longitude (DD)	-149.569984421

Photo Type: Soils

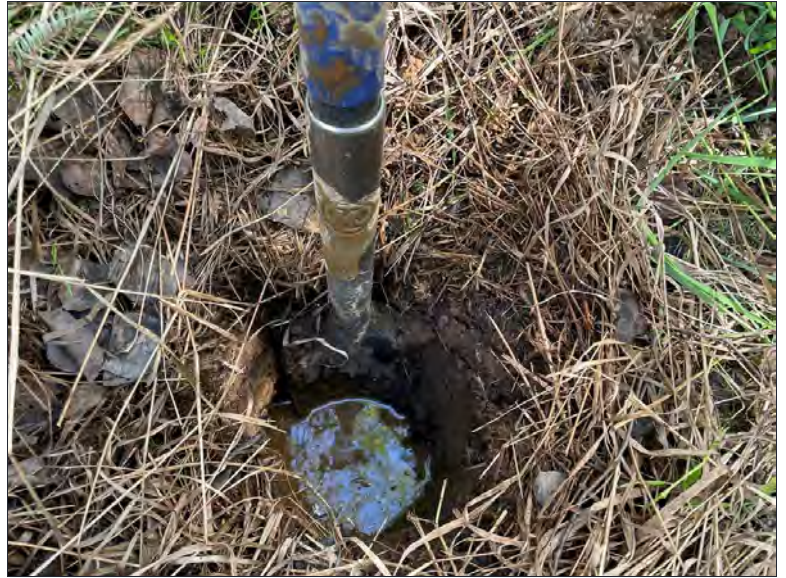
Photo Type: Soils

Plot Number	ST040
Wetland Status	Wetland
Plot Type	WD
Plot Date	6/10/2022
NWI Classification	PEM1/SS4C
HGM	Slope
Latitude (DD)	61.6177086117
Longitude (DD)	-149.569779182

Direction: NA
