**Wetlands and Waters Delineation  
Report**

**Seldon Road Extension Phase II**

CFHWY00562

August 12, 2022

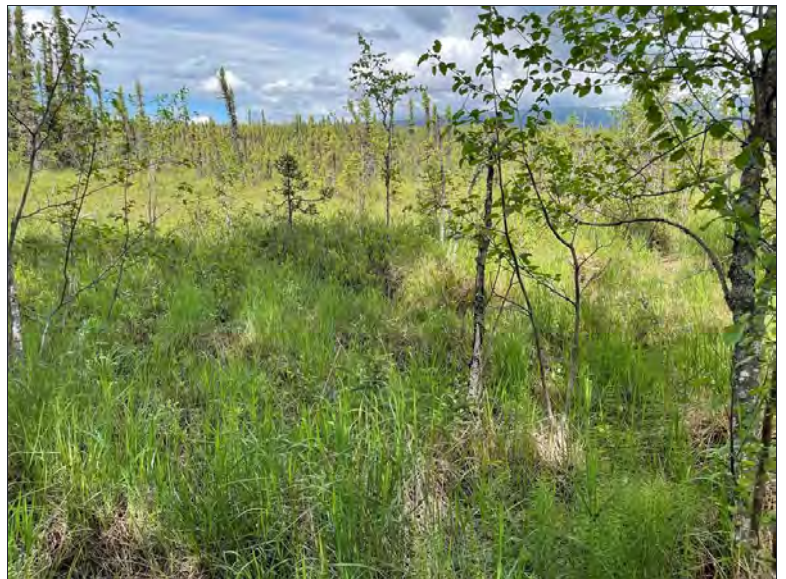
Photo Type: Vegetation

Direction: N

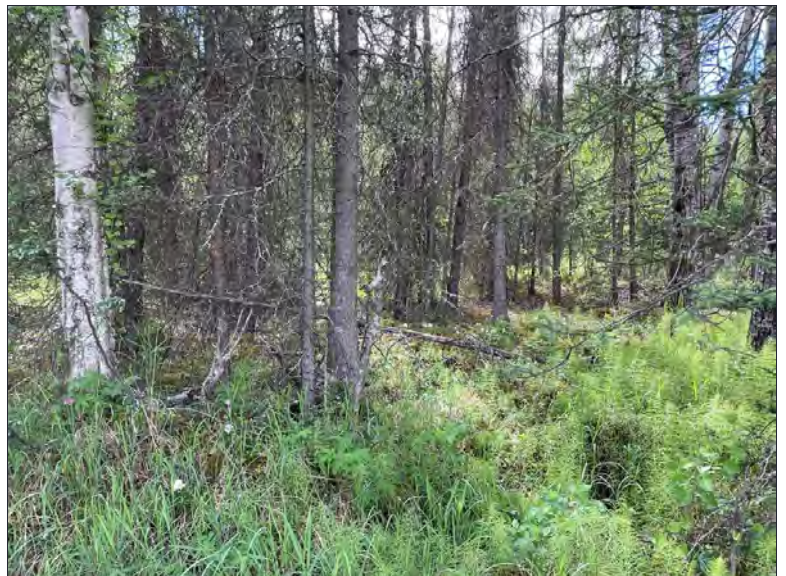
Photo Type: Vegetation

Direction: S

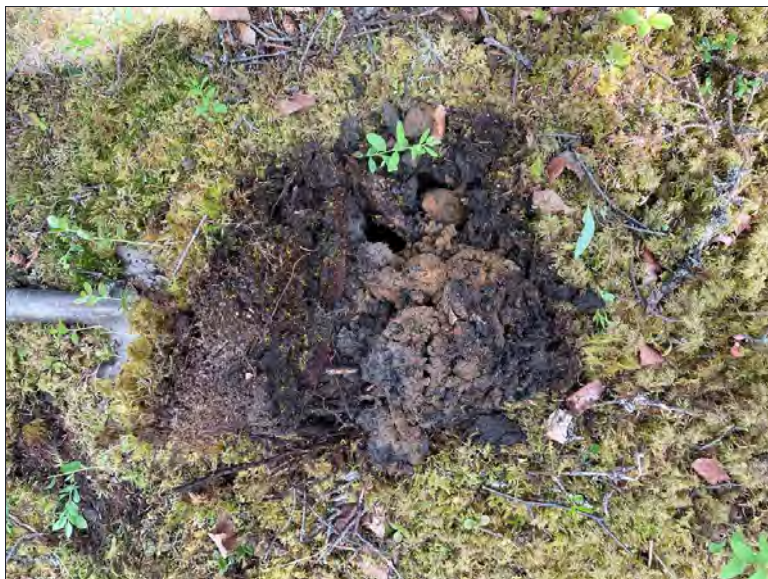
Photo Type: Soils

Plot Number	ST041
Wetland Status	Upland
Plot Type	FVP
Plot Date	6/10/2022
NWI Classification	U
HGM	N/A
Latitude (DD)	61.6178468392
Longitude (DD)	-149.570437564

Direction: NA

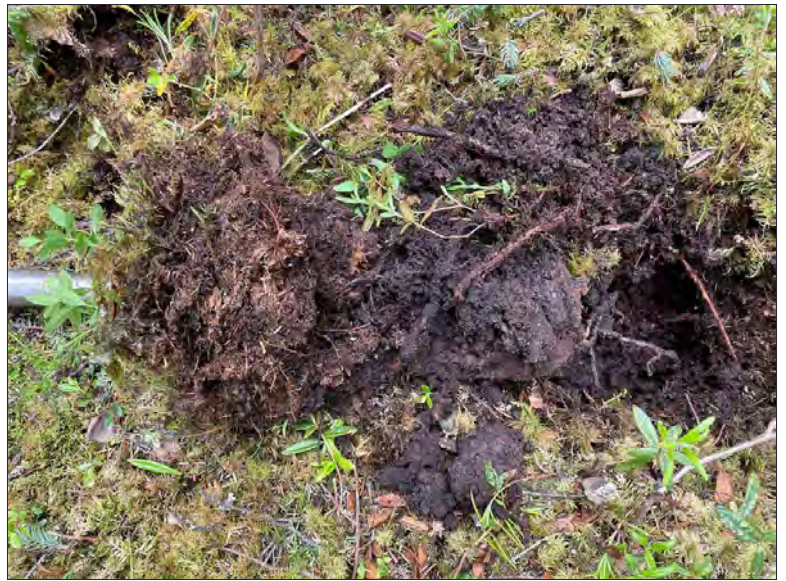
Photo Type: Soils

Plot Number	ST042
Wetland Status	Upland
Plot Type	FVP
Plot Date	6/10/2022
NWI Classification	U
HGM	N/A
Latitude (DD)	61.6172420419
Longitude (DD)	-149.568434941

Direction: NA

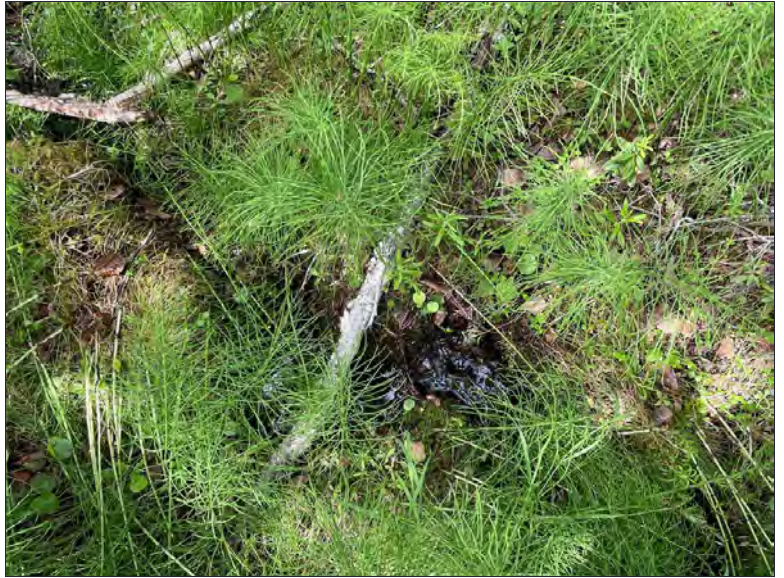
Photo Type: Hydrology

Plot Number	ST043
Wetland Status	Wetland
Plot Type	FVP
Plot Date	6/10/2022
NWI Classification	PFO4/EM1C
HGM	Slope
Latitude (DD)	61.6170619295
Longitude (DD)	-149.56774882

Direction: NA

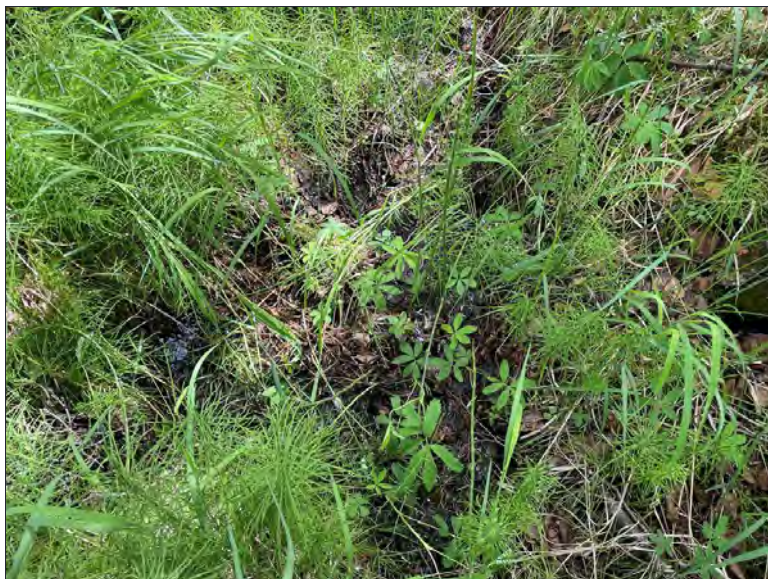
Photo Type: Hydrology

Plot Number	ST044
Wetland Status	Wetland
Plot Type	FVP
Plot Date	6/10/2022
NWI Classification	PFO4/1C
HGM	Slope
Latitude (DD)	61.6168419021
Longitude (DD)	-149.566976591

Direction: NA

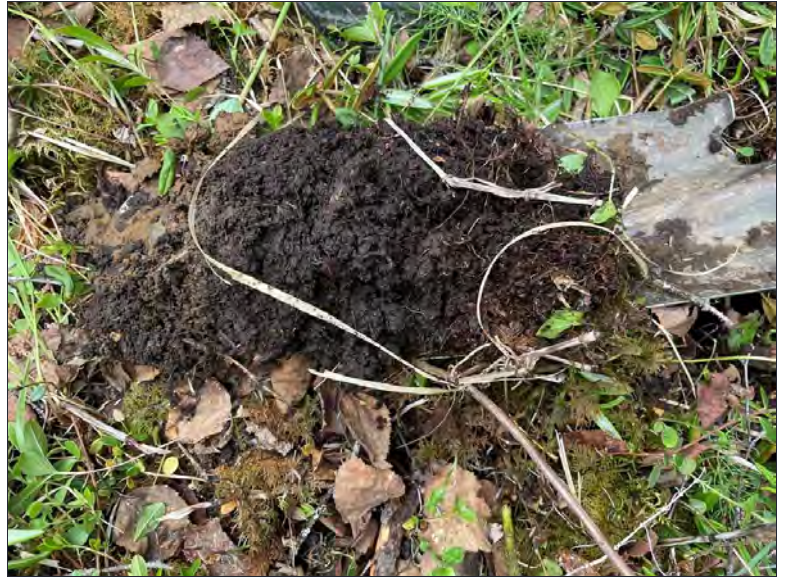
Photo Type: Soils

Plot Number	ST045
Wetland Status	Upland
Plot Type	FVP
Plot Date	6/10/2022
NWI Classification	U
HGM	N/A
Latitude (DD)	61.6167500021
Longitude (DD)	-149.567142272

Direction: NA

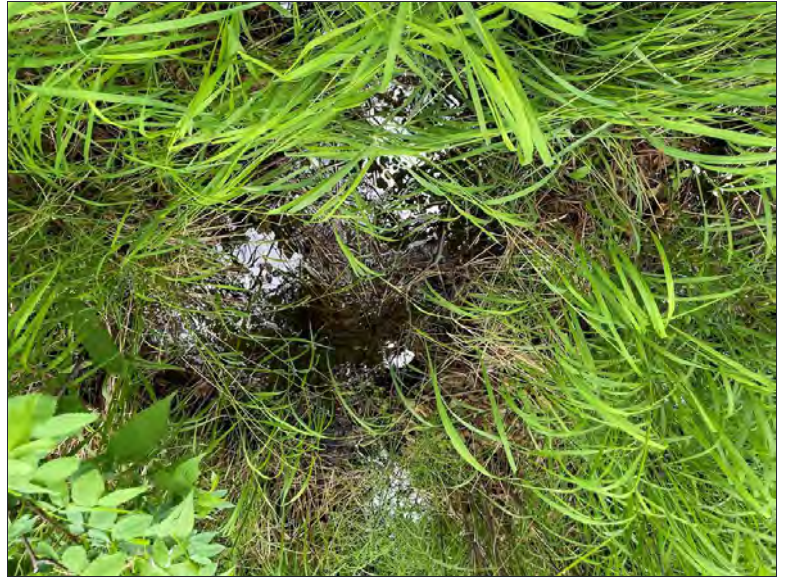
Photo Type: Hydrology

Plot Number	ST046
Wetland Status	Wetland
Plot Type	FVP
Plot Date	6/10/2022
NWI Classification	PFO1/EM1C
HGM	Slope
Latitude (DD)	61.6166661903
Longitude (DD)	-149.567408547

Direction: NA

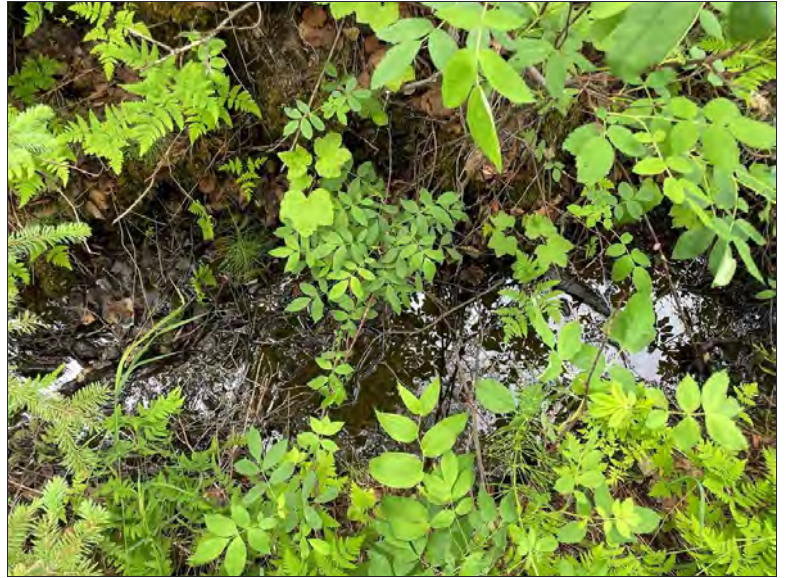
Photo Type: Hydrology

Plot Number	ST047
Wetland Status	RPW
Plot Type	SC
Plot Date	6/10/2022
NWI Classification	R3UBH
HGM	Riverine Channel
Latitude (DD)	61.6164863645
Longitude (DD)	-149.566683845

Direction: NA

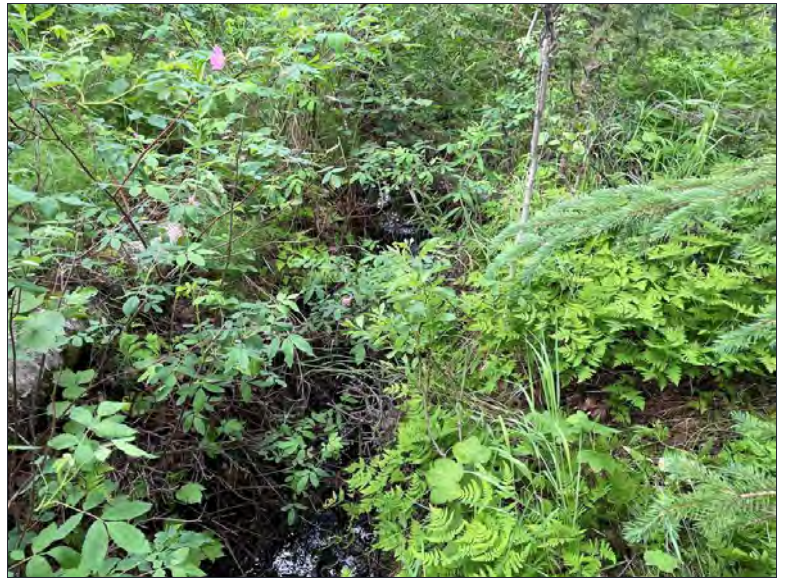
Photo Type: Hydrology

Direction: NW

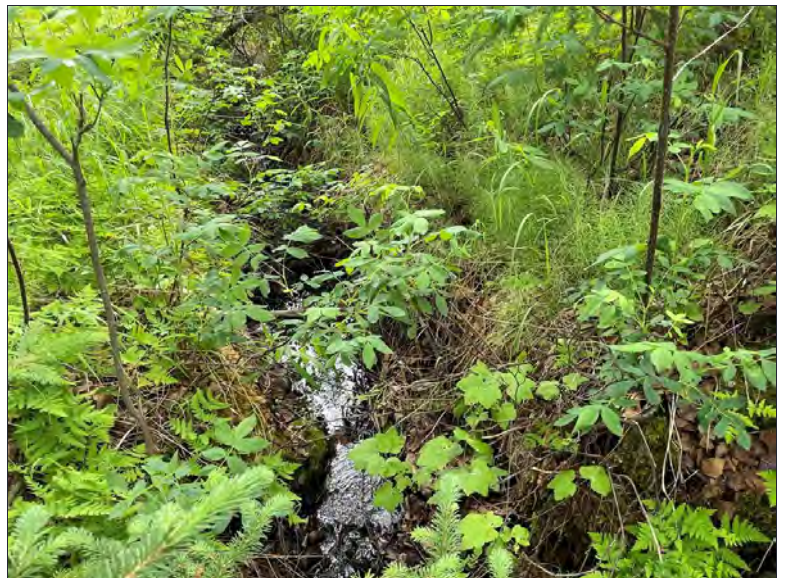
Photo Type: Hydrology

Direction: SE

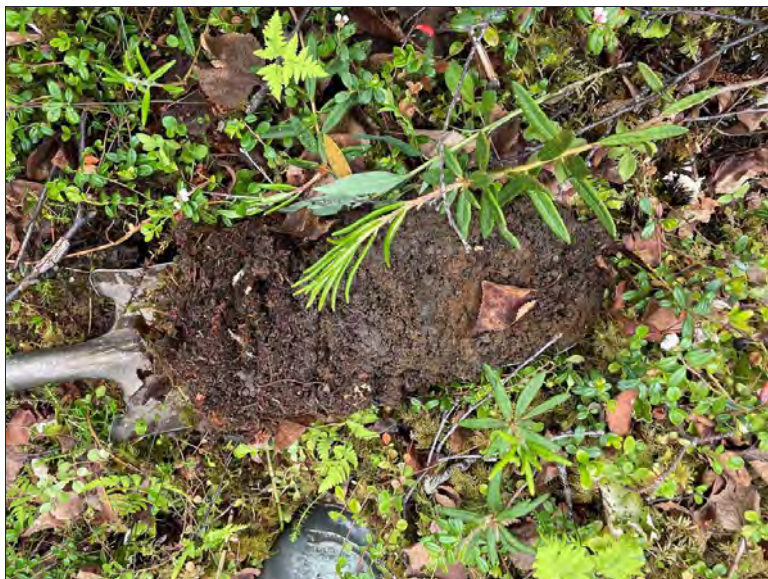
Photo Type: Soils

Plot Number	ST048
Wetland Status	Upland
Plot Type	FVP
Plot Date	6/10/2022
NWI Classification	U
HGM	N/A
Latitude (DD)	61.6166076566
Longitude (DD)	-149.566463187

Direction: NA

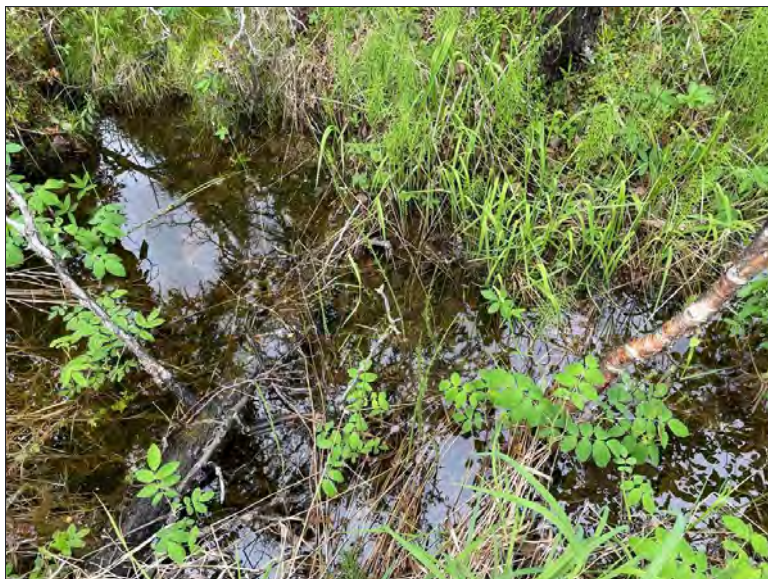
Photo Type: Hydrology

Plot Number	ST049
Wetland Status	Wetland
Plot Type	FVP
Plot Date	6/10/2022
NWI Classification	PFO4/1C
HGM	Slope
Latitude (DD)	61.616684268
Longitude (DD)	-149.566276628

Direction: NA

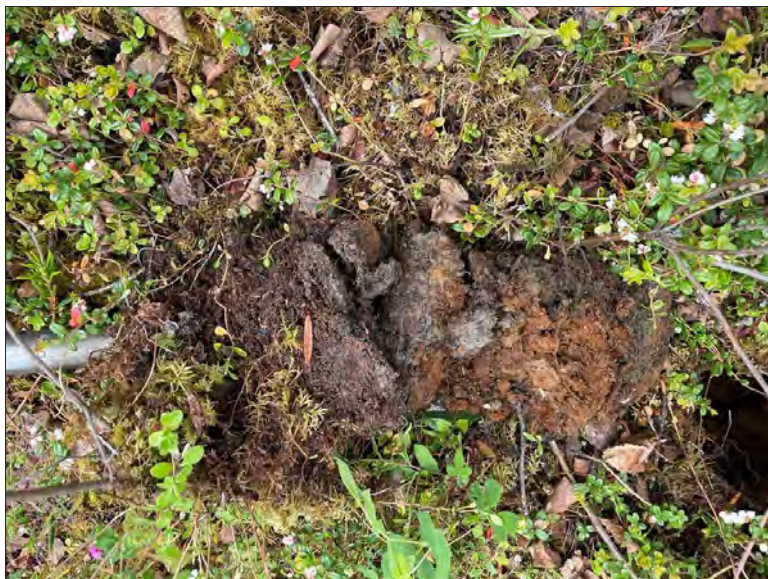
Photo Type: Soils

Plot Number	ST050
Wetland Status	Upland
Plot Type	FVP
Plot Date	6/10/2022
NWI Classification	U
HGM	N/A
Latitude (DD)	61.6165165022
Longitude (DD)	-149.565794211

Direction: NA

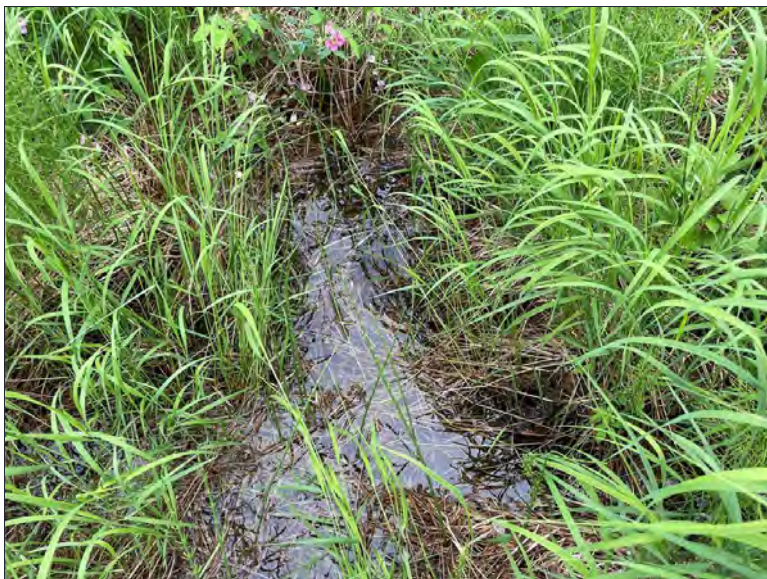
Photo Type: Hydrology

Plot Number	ST051
Wetland Status	Wetland
Plot Type	FVP
Plot Date	6/10/2022
NWI Classification	PEM1C
HGM	Slope
Latitude (DD)	61.6164966169
Longitude (DD)	-149.565547488

Direction: NA

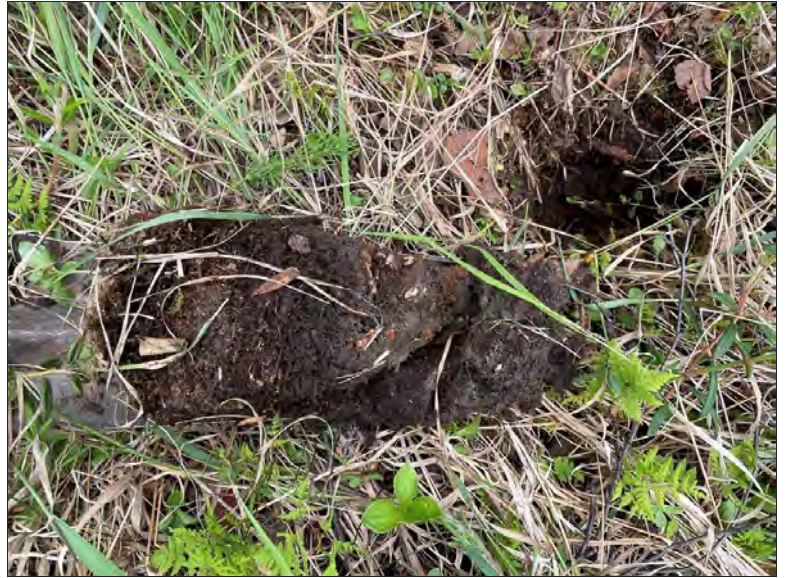
Photo Type: Soils

Plot Number	ST052
Wetland Status	Upland
Plot Type	FVP
Plot Date	6/10/2022
NWI Classification	U
HGM	N/A
Latitude (DD)	61.616483975
Longitude (DD)	-149.565213229

Direction: NA

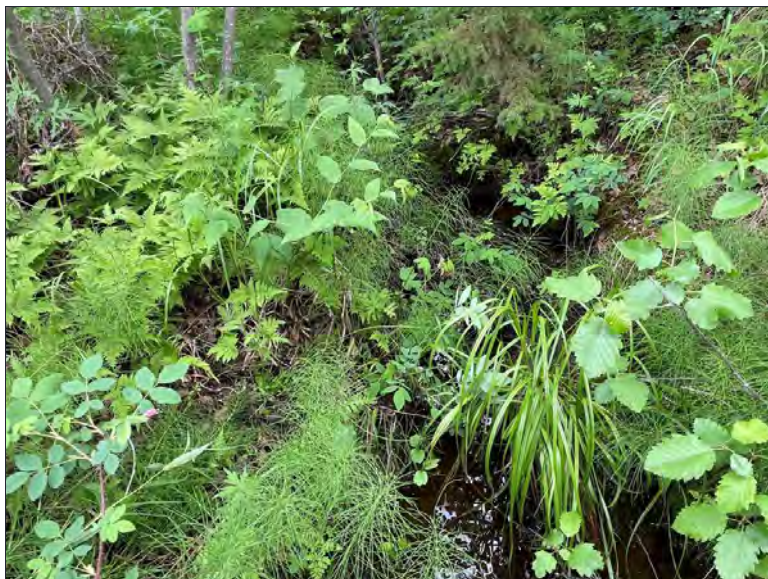
Plot Number	ST053
Wetland Status	RPW
Plot Type	SC
Plot Date	6/10/2022
NWI Classification	R3UBH
HGM	Riverine Channel
Latitude (DD)	61.6164245759
Longitude (DD)	-149.565039364

Photo Type: Hydrology

Direction: N

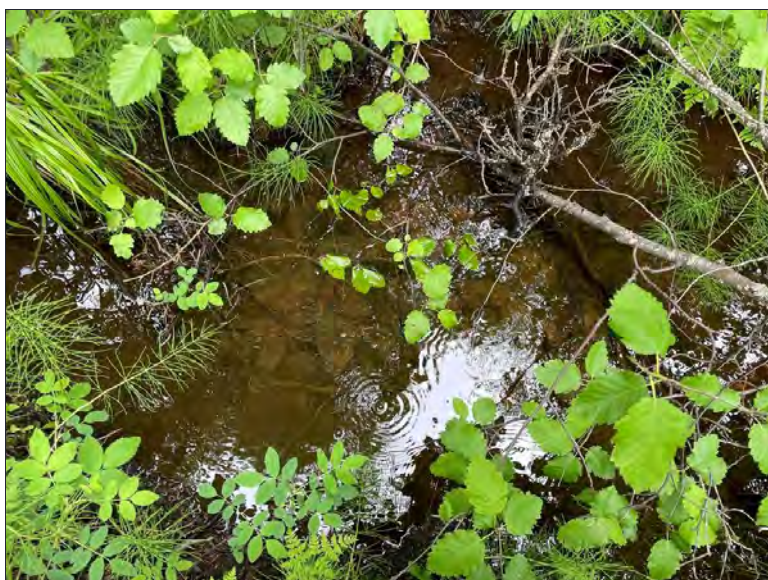
Photo Type: Hydrology

Direction: NA

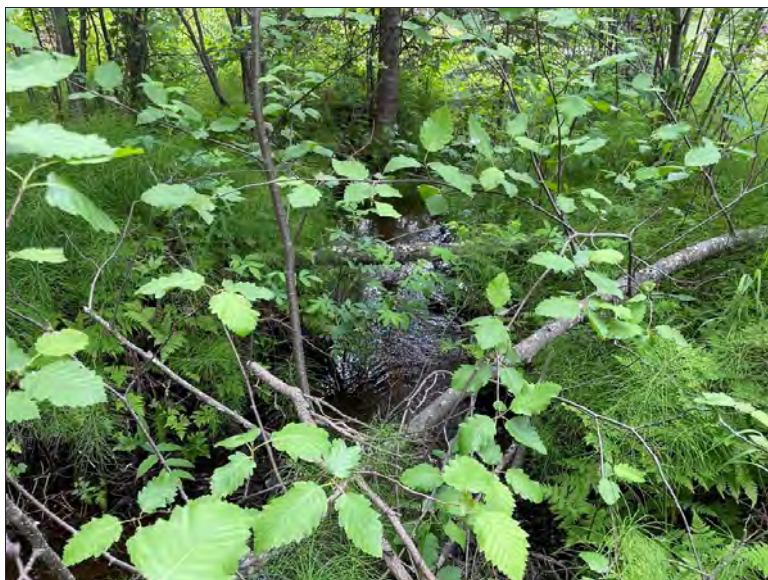
Photo Type: Hydrology

Direction: S
