APPENDIX D

Eagle Nest Survey

Project/File: Seldon Road Extension Phase II, Project # CFHWY00562

Reference: Eagle Nest Survey

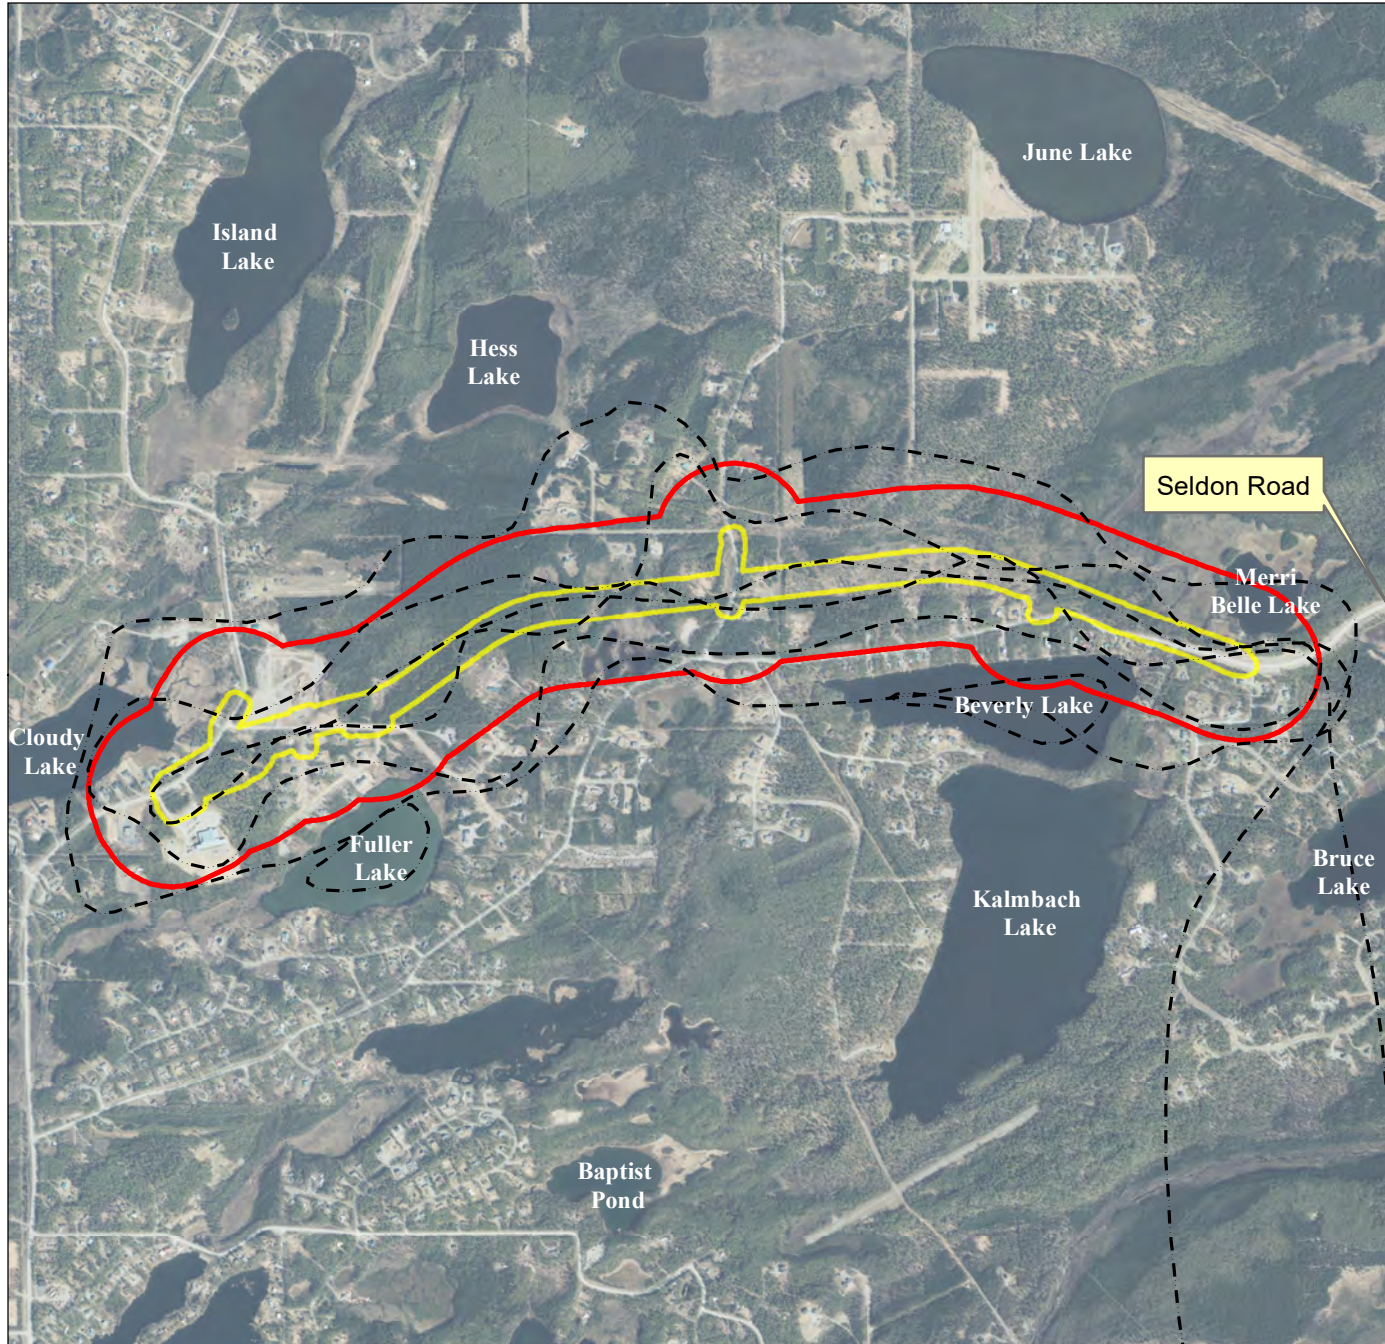
Department of Transportation and Public Facilities
 Seldon Road Extension Phase II
 Figure No.
1
 Title
Project Map

The study area was created by drawing a 660-foot buffer from the project study area (Figure 1). The project study area is slightly larger than the proposed footprint of the project. This method allowed for a conservative (slightly larger) survey area for nests around the project. The rotor wing survey also purposely flew outside the study area, to inspect habitat along the edge of the 660-foot buffer.

The flight took place between 9:00 and 9:30 am on Thursday, June 2, 2022. The flight paths were laid out to provide overlapping surveys of all the habitat. Multiple passes were conducted from different viewing angles for each part of the project. Flight paths are depicted on Figure 1.

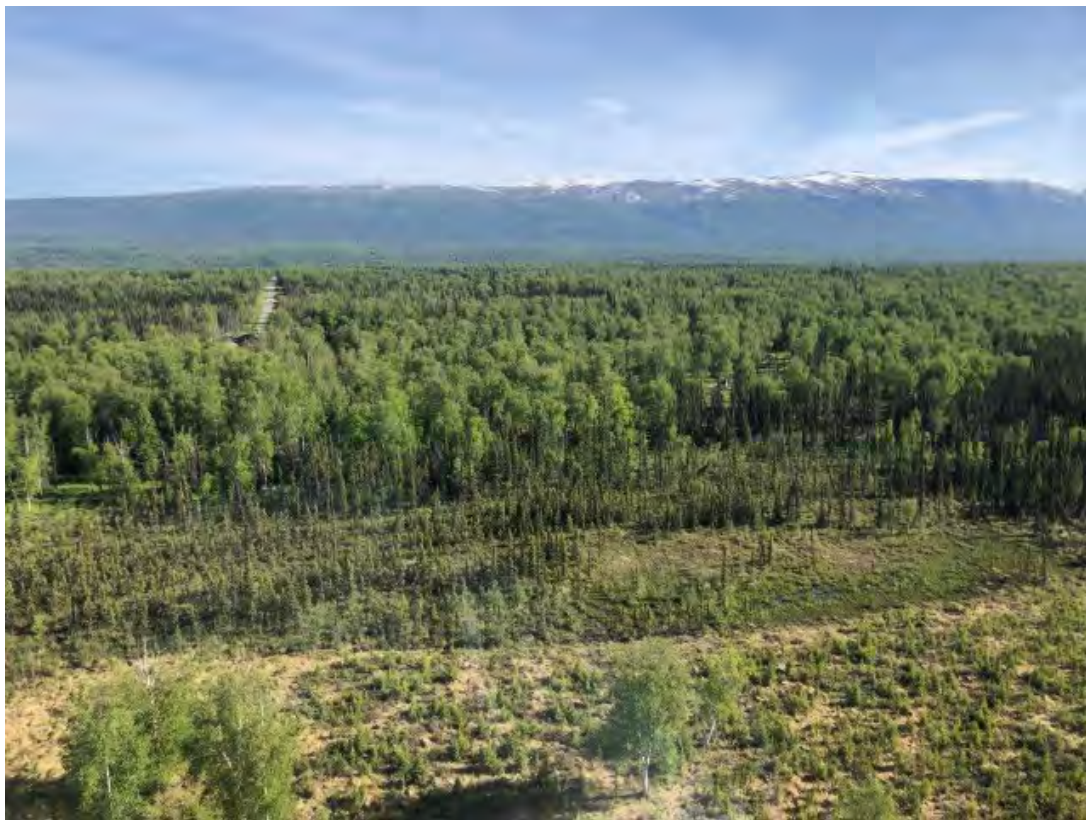
The weather was 65-70 degrees Fahrenheit, with clear blue skies. The sun was bright and shining from the east. There was no precipitation, fog, or other weather hindrances to visibility. Leaf out had already occurred, and trees were in full foliage (Figure 2, 3).

Figure 2: Sample photo #1 of vegetation observed during the survey

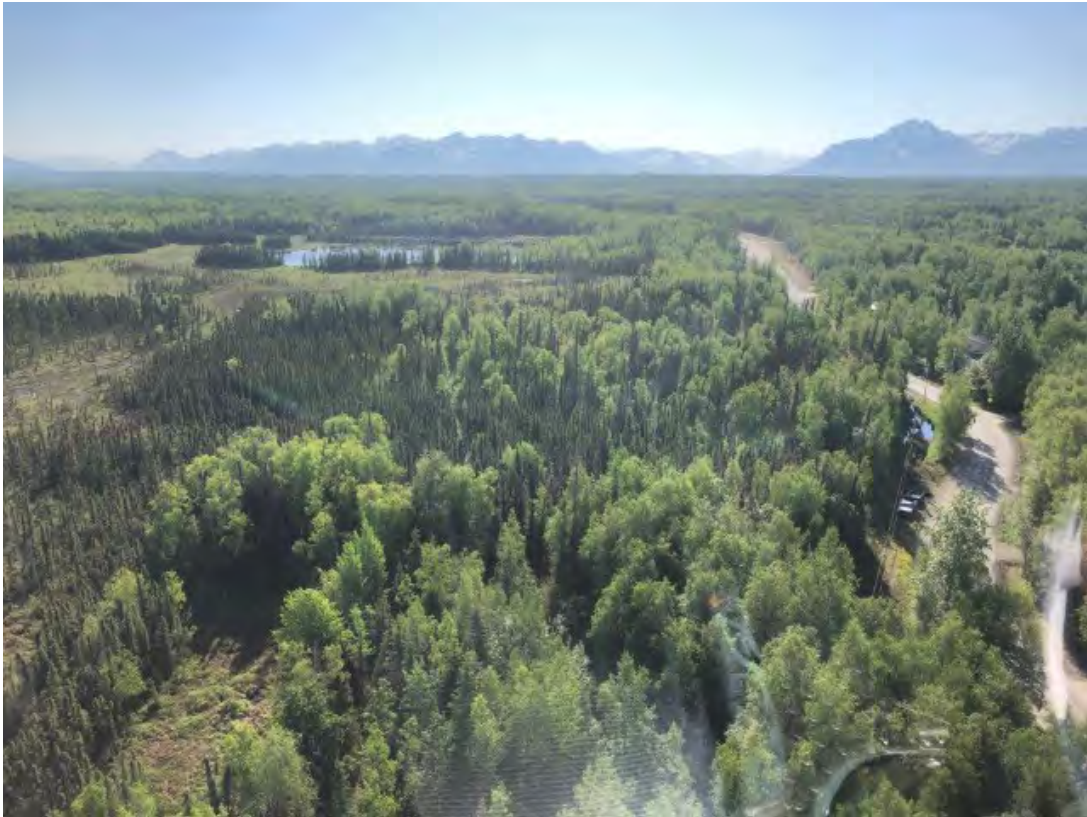
Figure 3: Sample photo #2 of vegetation observed during the survey
